**BRIEF ON JOINT INVESTIGATION VISIT (JIV) AT MOSAN PIPELINE INCIDENT SITE, ALIMOSHO LOCAL GOVERNMENT AREA OF LAGOS STATE ON THE 9<sup>TH</sup> OF APRIL, 2020**

**1. COMPANY ADDRESS/FACILITY DETAILS**

Joint Investigation Visit (JIV) to ascertain the cause of incident, quantity of product spilled and extent of the impact on the environment.

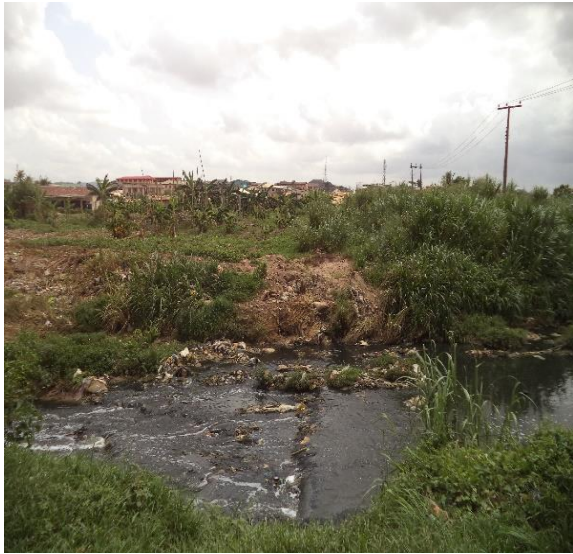
- a) The affected pipeline is located across a canal separating Mosan and Aboru communities
- b) The pipeline has been repaired and covered
- c) The atmosphere around the incident area was no longer pungent with product fumes
- d) Product pumped through the pipeline is Premium Motor Spirit (PMS)
- e) No visible sign of security surveillance/patrol
- f) The area along the Right of way was cluttered with both refuse and vegetation
- g) Some pipeline right of way marker posts were visible while others have been removed

- a. "Repair work" is sometimes carried out on the pipeline by unidentified personnel (according to the residents).
- b. Product was not spilled according to NPSC as there was not breakage in the pipeline.
- c. The valve installed by the vandals had been removed by NPSC staff and product pumping has resumed.

Pic 1: Section of repaired Pipeline

- a. Properly delineate and always clear the Pipeline right of way
- b. Provide effective security to monitor activities around the pipeline and the community.
- c. Be directed to collaborate with other stakeholders in sensitization of the community as well as all pipeline host communities on the dangers of pipeline vandalism.
