*PHOTOGRAPHS TAKEN DURING JIV AT 6" Deep 6 Ogboinbiri Flowline At Ogboinbiri  
In Southern Local Government Area Of Bayelsa State.*

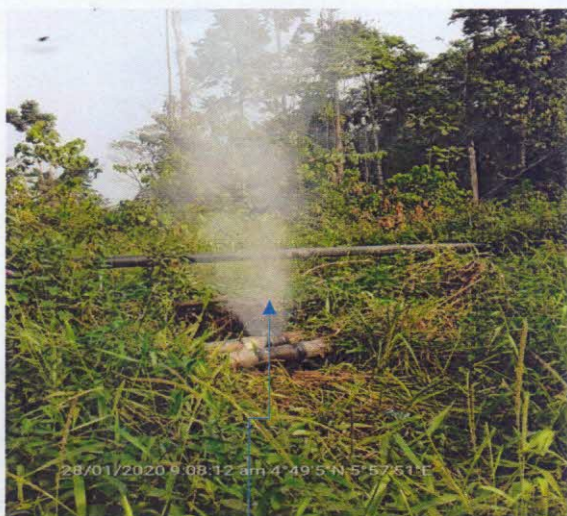
**GASEOUS EMISSION FROM SPILL POINT**

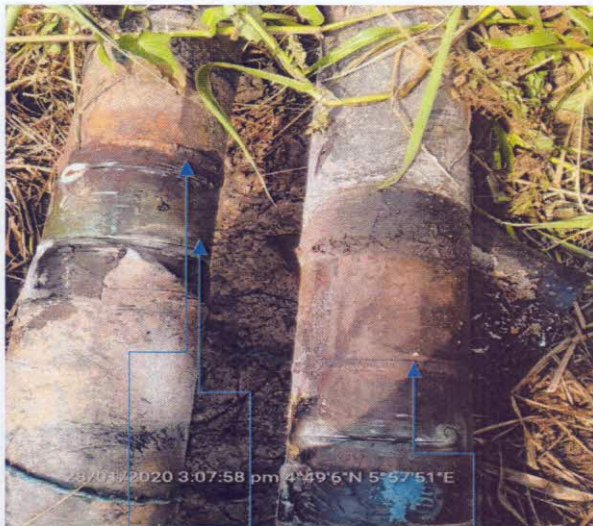
**THREE HACKSAW CUTS ON THE FLOWLINE**

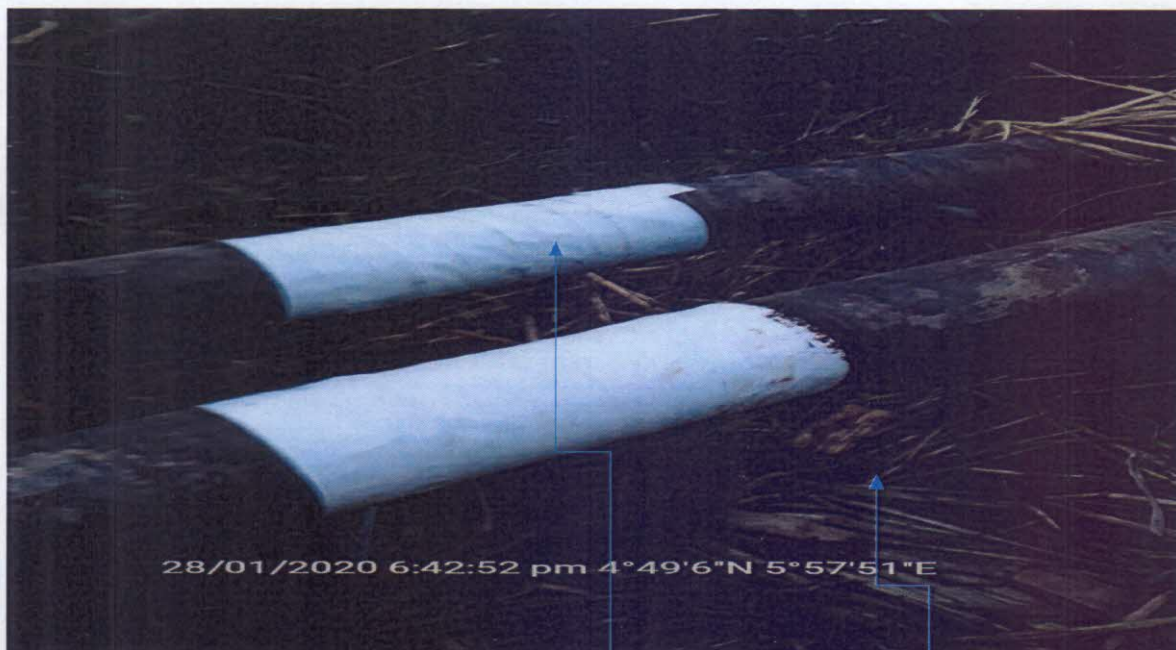
**REPAIR POINT (WRAPPED)**

**WITHERED VEGETATION**
