# APPENDIX I

## SOME PHOTOGRAPHS TAKEN DURING THE JOINT INVESTIGATION VISIT (JIV)

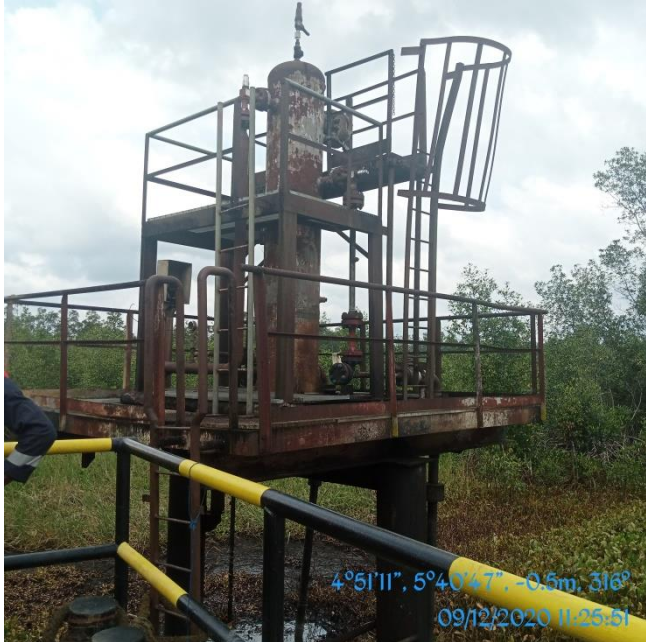
Fig A: Incident Facility (Clough Creek 2 Manifold)

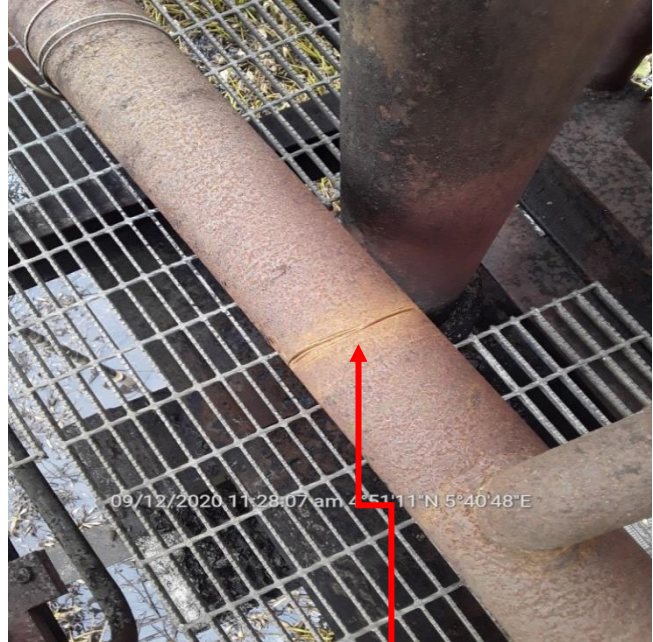
Fig B: Hacksaw cut inflicted by Vandals

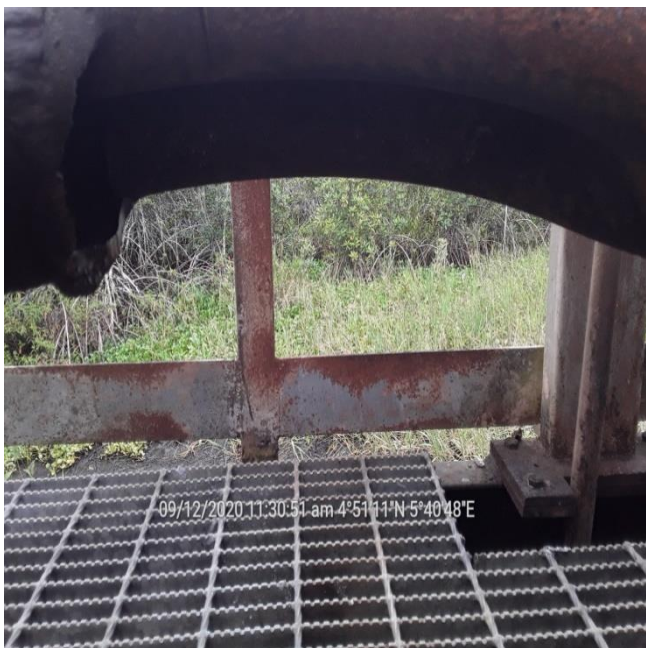
Fig C: Vandalized 4\" Gas F/L

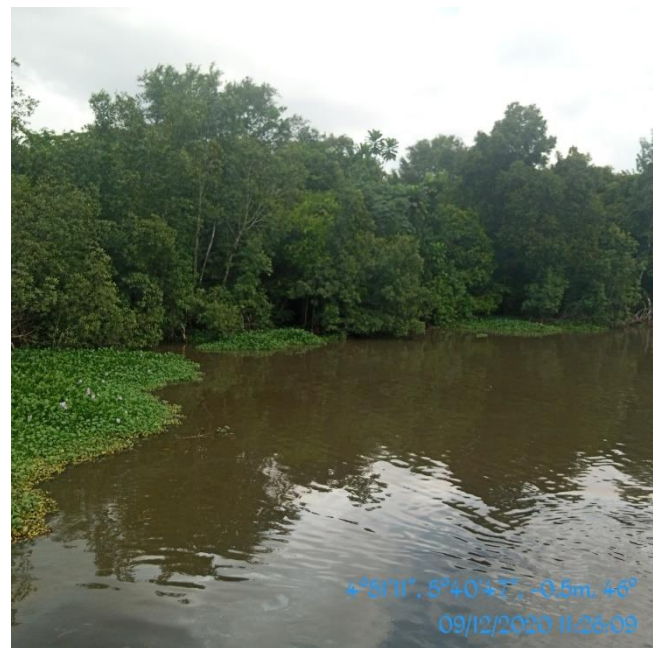
Fig D: Adjoining Environment/Green Vegetation
