## APPENDIX I

### SOME PHOTOGRAPHS TAKEN DURING THE JOINT INVESTIGATION VISIT (JIV)

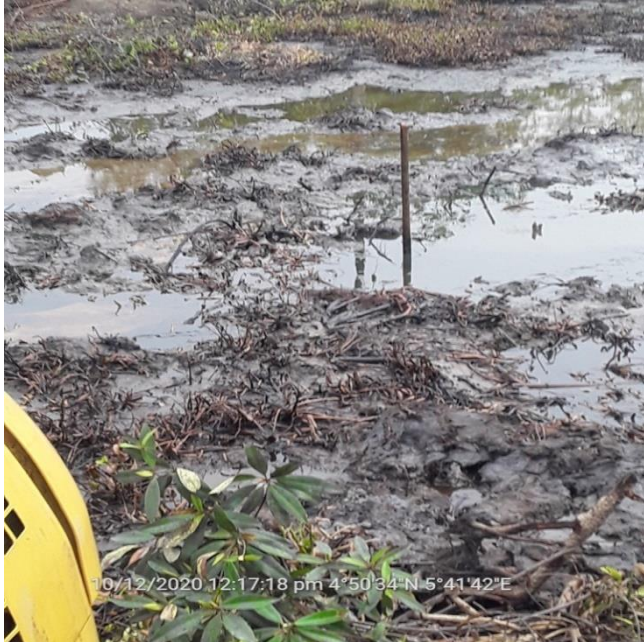
**Fig A: Incident Area on arrival of JIT**

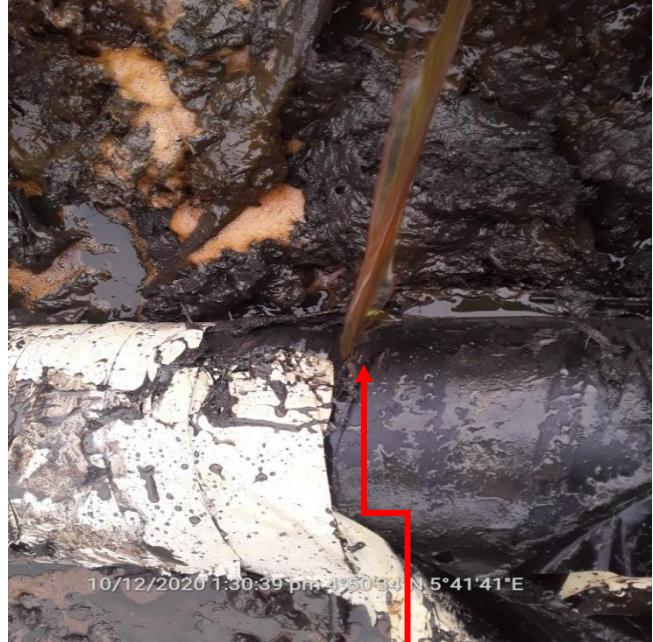
**Fig B: Incident Facility shortly after excavation**

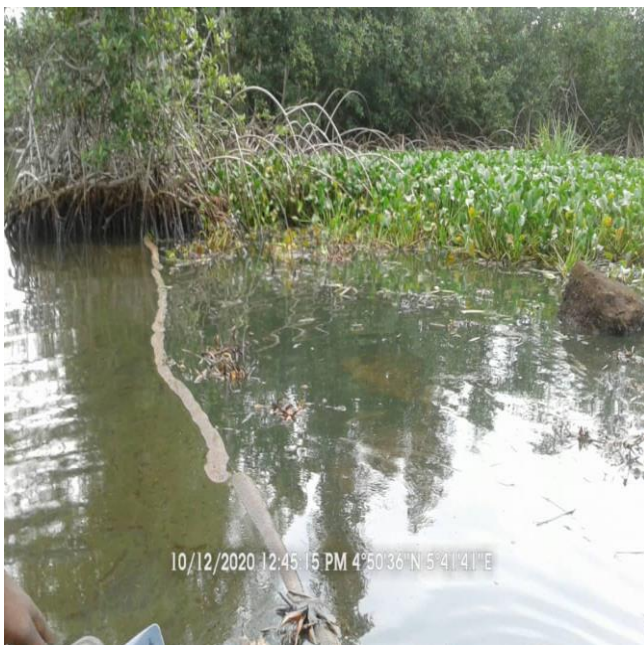
**Fig C: Crude oil impact on the environment**
