## APPENDIX I

### SOME PHOTOGRAPHS TAKEN DURING THE JOINT INVESTIGATION VISIT (JIV)

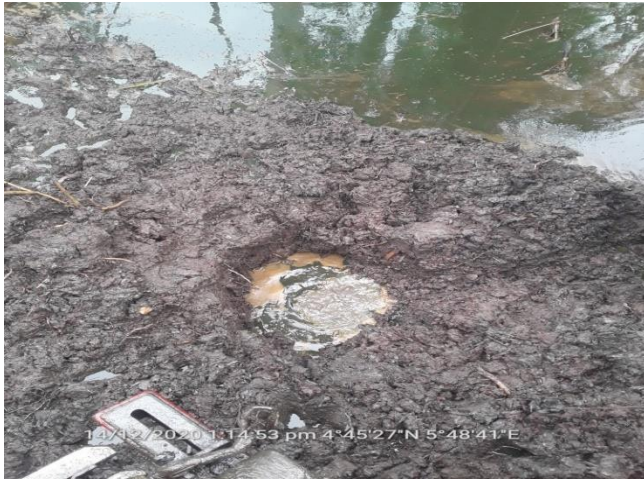
**Fig A: Incident Area on arrival of JIT**

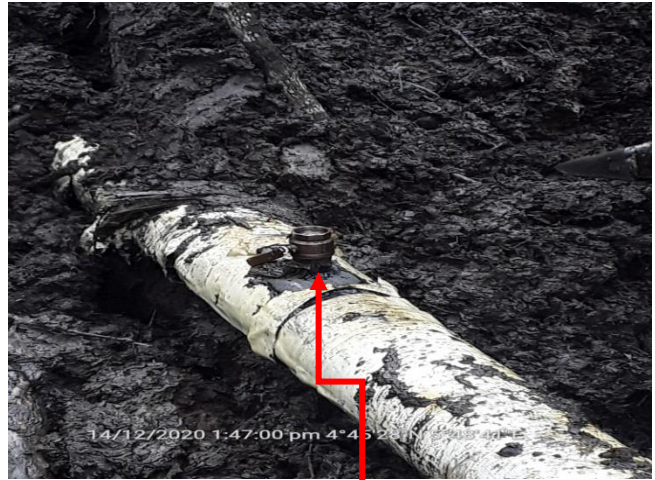
**Fig B: Incident Facility shortly after excavation**

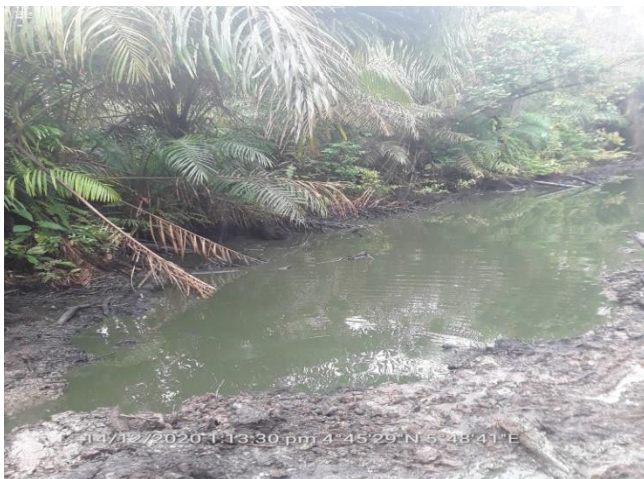
**Fig C: Oil spill impact**

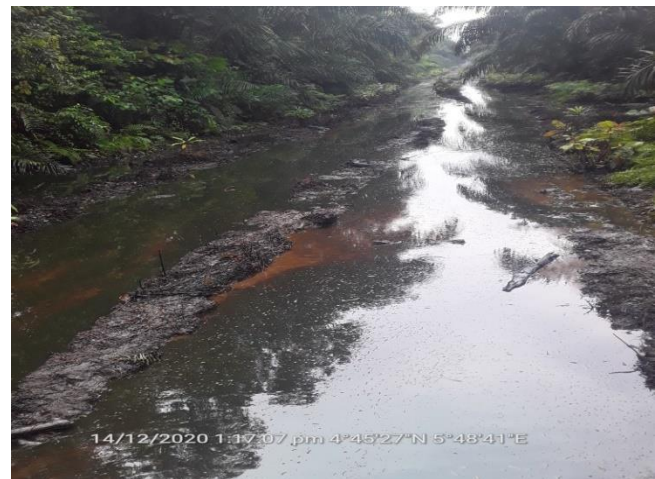
**Fig D: NAOC's RoW/Impact**
