## APPENDIX I

### SOME PHOTOGRAPHS TAKEN DURING THE JOINT INVESTIGATION VISIT (JIV)

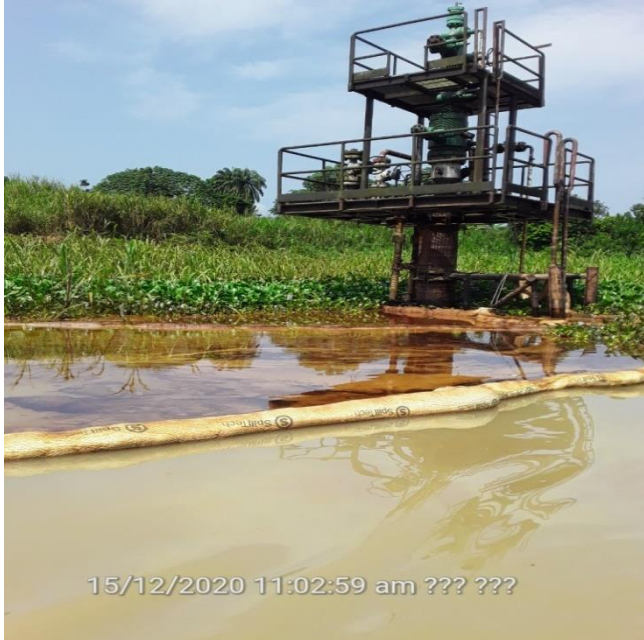
Fig A: Incident Facility (Ogboinbiri Well 7 TBG)

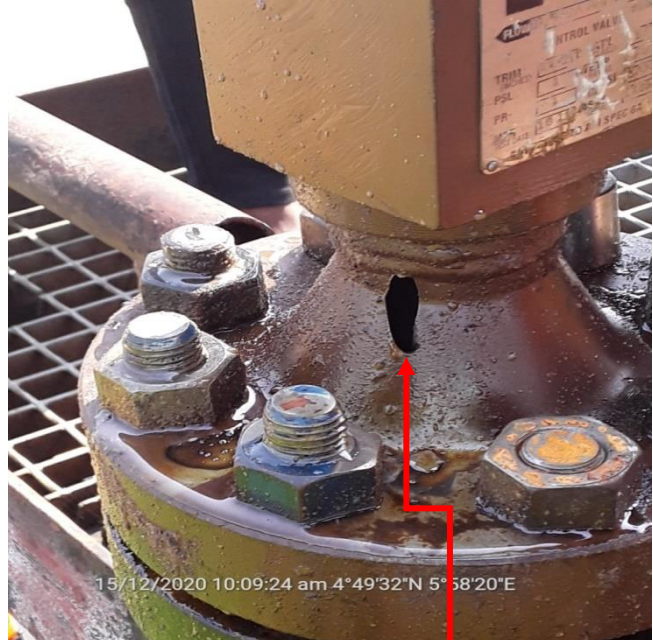
Fig B: Rupture on the Well 7 choke box

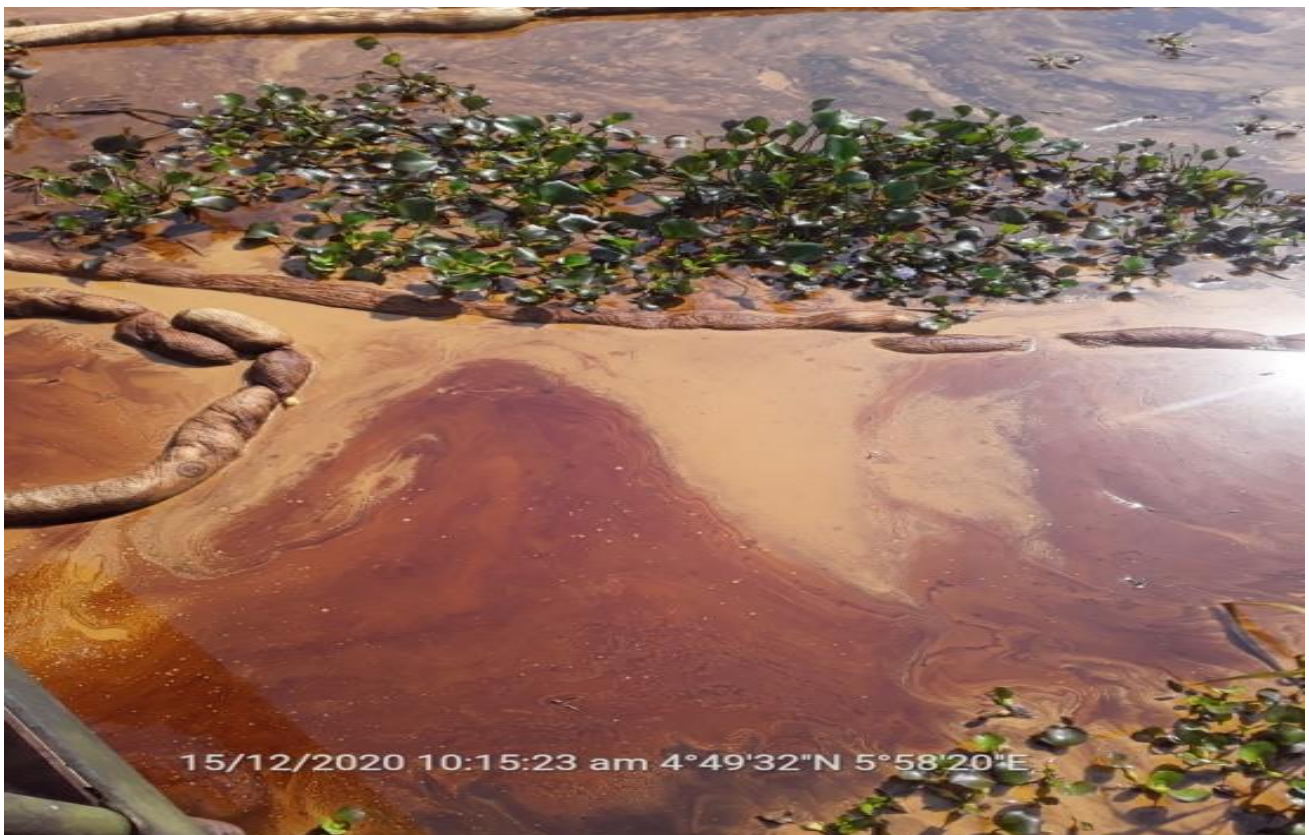
Fig C: Oil Spill Impact
