# PHOTOGRAPHS TAKEN ON SITE

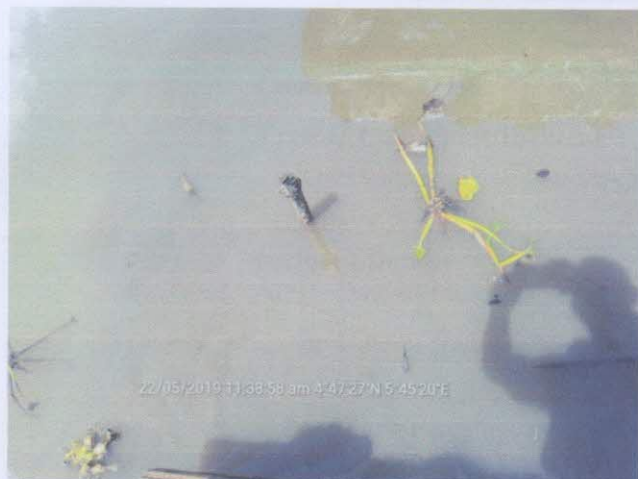
**FIG A: Incident point on arrival**

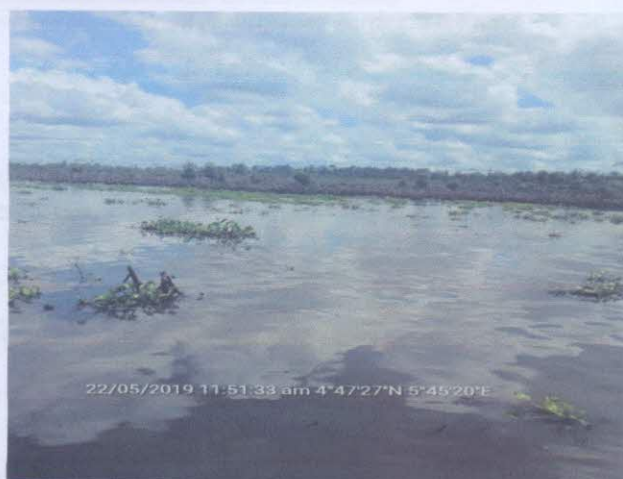
**FIG B: Incident area environment**

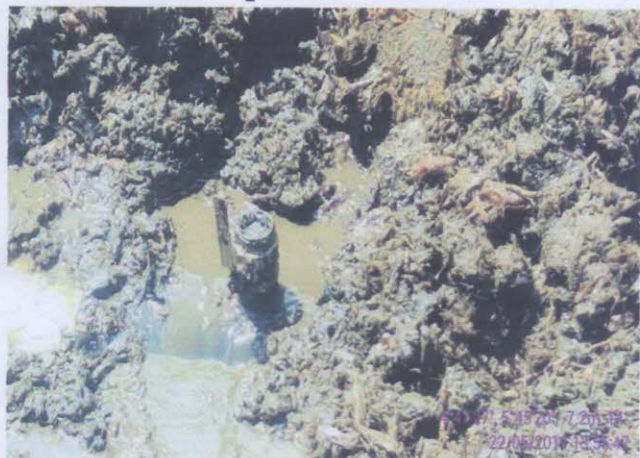
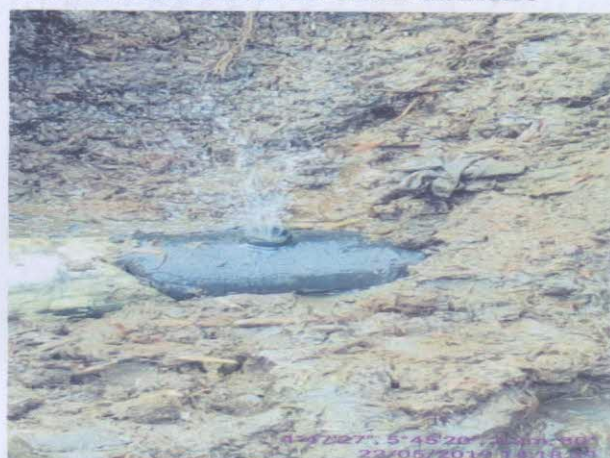
**FIG C-D: Incident point on exposure**
