## PHOTOGRAPHS TAKEN ON SITE

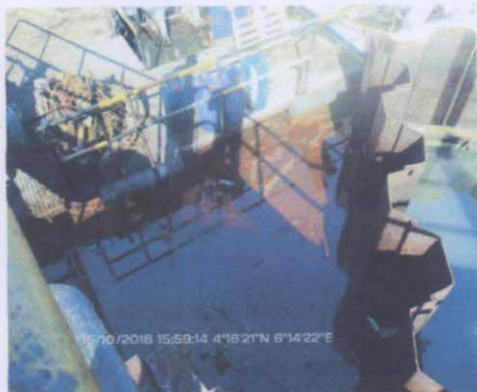
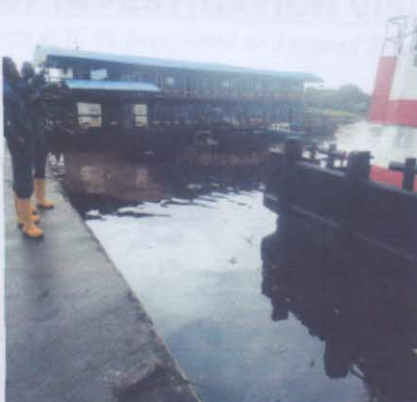
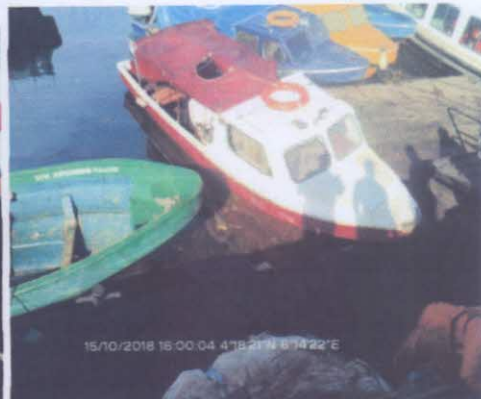
**FIG A-C: Impact around the NAOC Terminal and dockyard area**

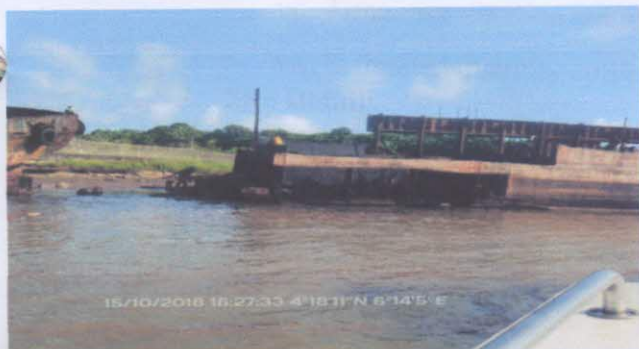
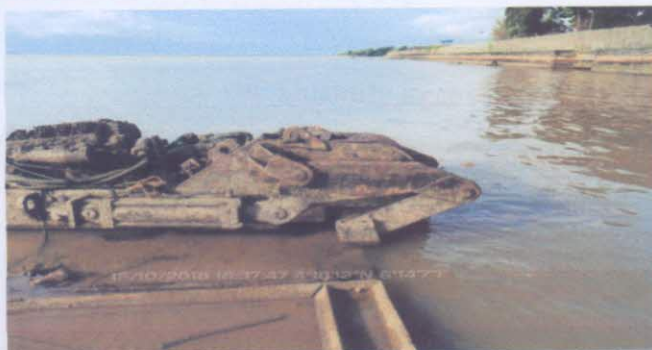
**FIG D-E: NAOC alleged incident area showed no evidence of oiling**

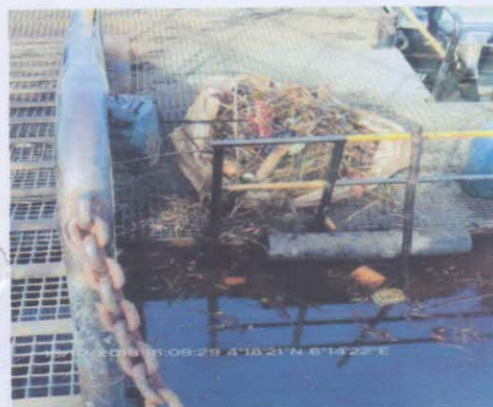
**FIG F: Debris collected**

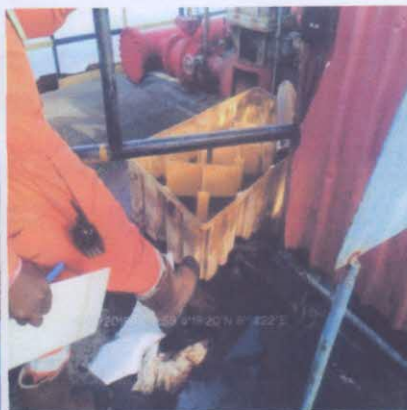
**FIG G: Incident point**

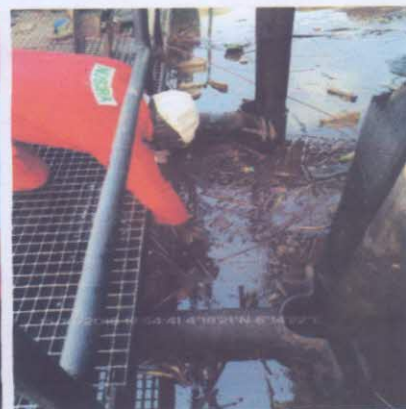
**FIG H: Sample collection at dock area**

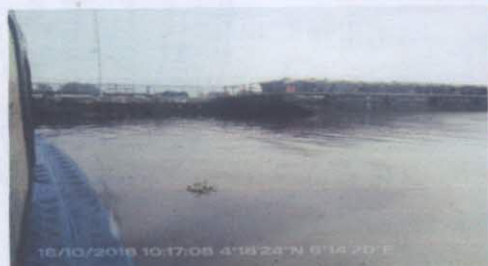
**FIG I: Impact on the Brass Canal**

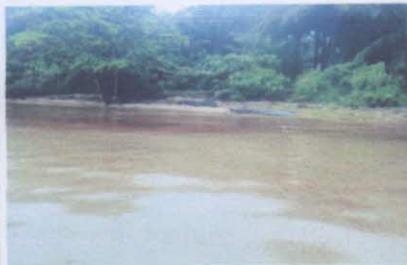
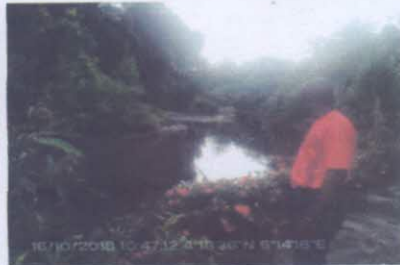
**Fig J-K: Impact along community waterfront and creek**
