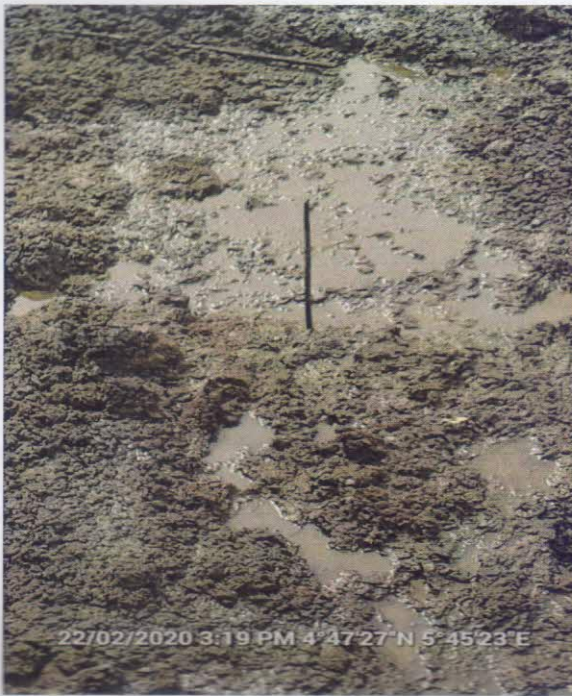
**NO TRACE OF OIL AT THE SPILL POINT.**
