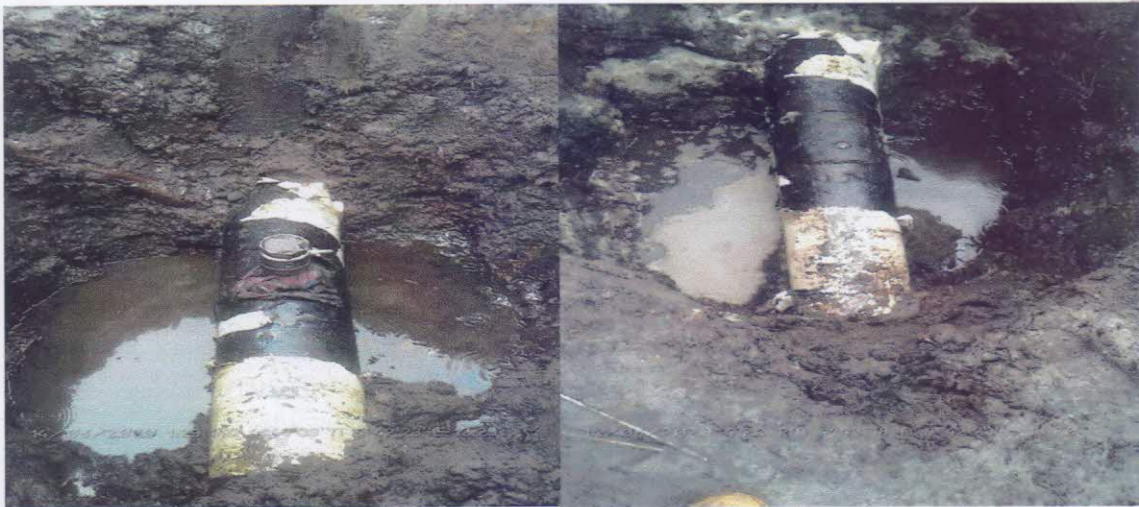
**Pictures 1&2 showing installed valve at spill point and repaired point.**
