**PHOTOGRAPHS TAKEN DURING JIV AT 6" OGBOINBIRI/TEBIDABA PIPELINE AT OKPOTUWARI  
IN SOUTHERN IJAW LOCAL GOVERNMENT AREA OF BAYELSA STATE**

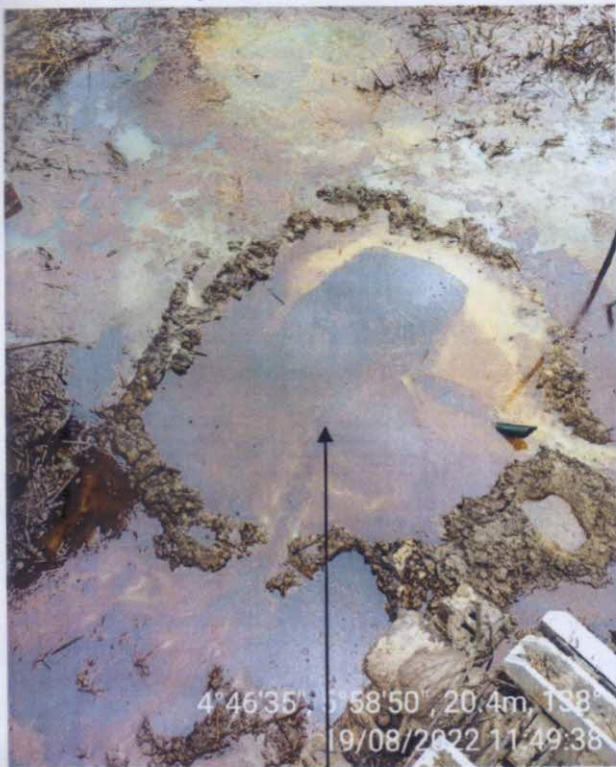
**SPILL POINT BEFORE EXCAVATION**

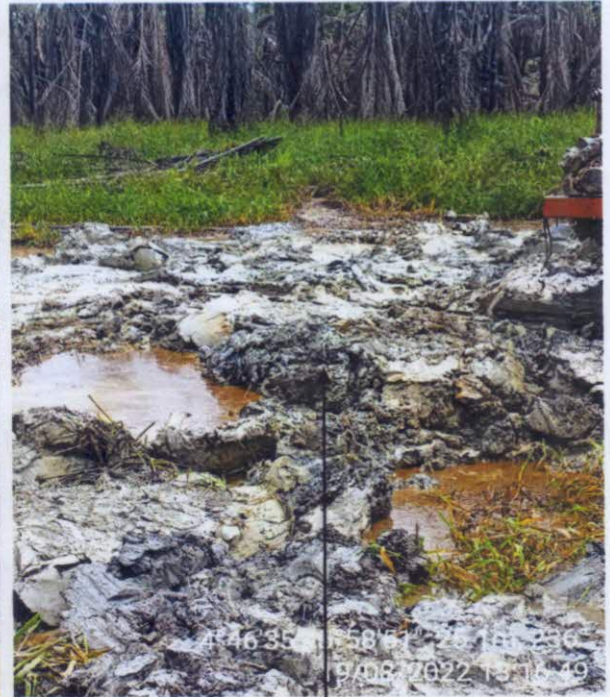
**IMPACTED AREA**
