**APPENDIX A:**

**PHOTOGRAPHS TAKEN DURING JIV AT 14" OGBOINBIRI/TEBIDABA PIPELINE AT IKEBIRI IN SOUTHERN IJAW LOCAL GOVERNMENT AREA OF BAYELSA STATE**

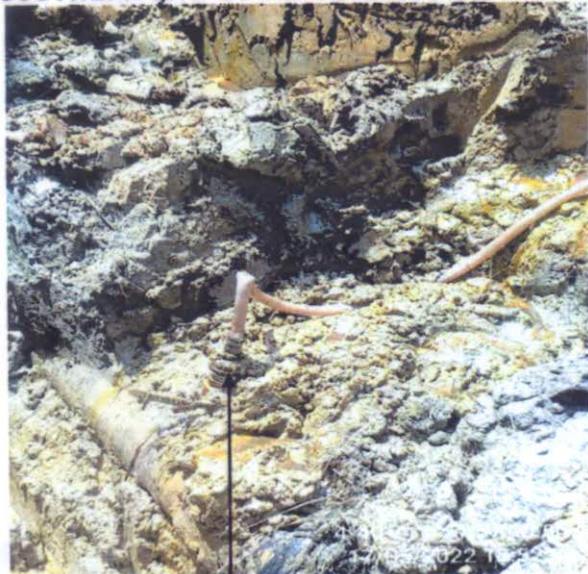
**SPILL POINT** (1"galvanize pipe with hose connected to the 3" valve at 12 O'clock position on the 14" pipeline)
