# APPENDIX A:

PHOTOGRAPHS TAKEN DURING JIV AT 14" OGBOINBIRI/TEBIDABA PIPELIE AT AZUZUAMA IN SOUTHERN IJAW LOCAL GOVERNMENT AREA OF BAYELSA STATE

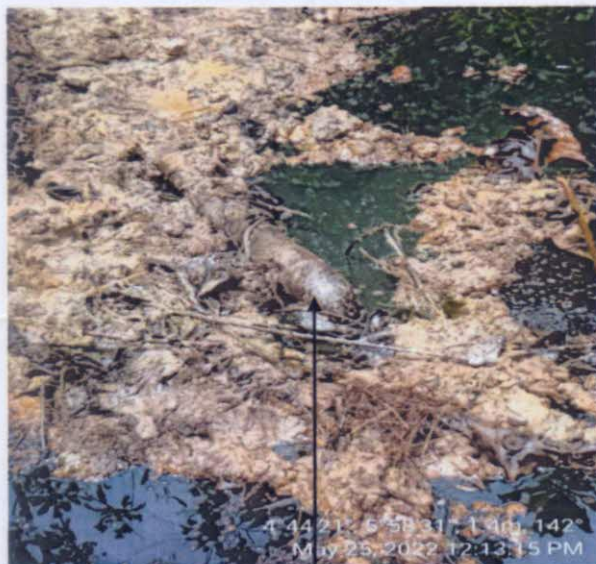
**SPILL POINT** (Before excavation)

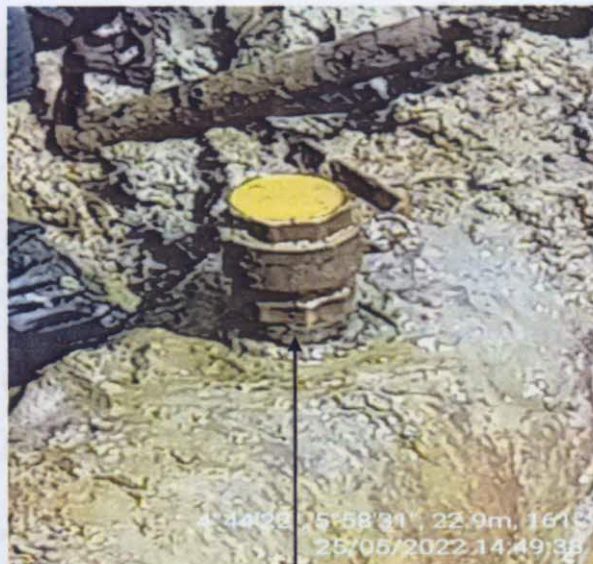
**SPILL POINT** (After excavation: Installed 3" valve at 12 O'clock position on the 14" pipeline)

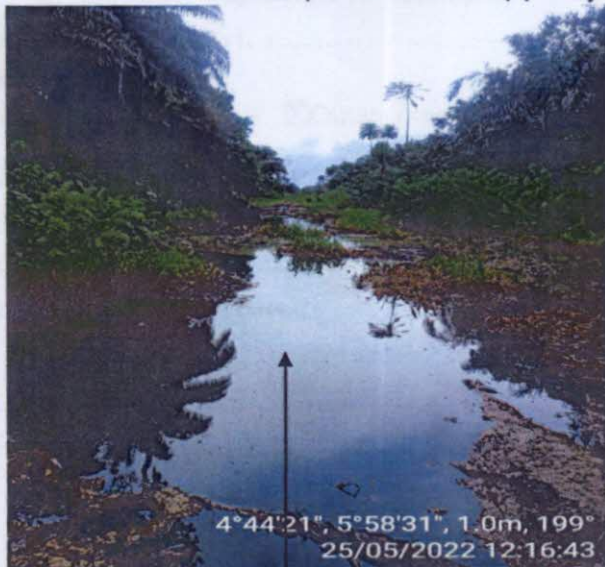
**IMPACTED AREA**
