APPENDIX A:

PHOTOGRAPHS TAKEN DURING JIV AT 6" OGBOINBIRI/TEBIDABA PIPELIE AT IKEINGHENBIRI IN SOUTHERN IJAW LOCAL GOVERNMENT AREA OF BAYELSA STATE

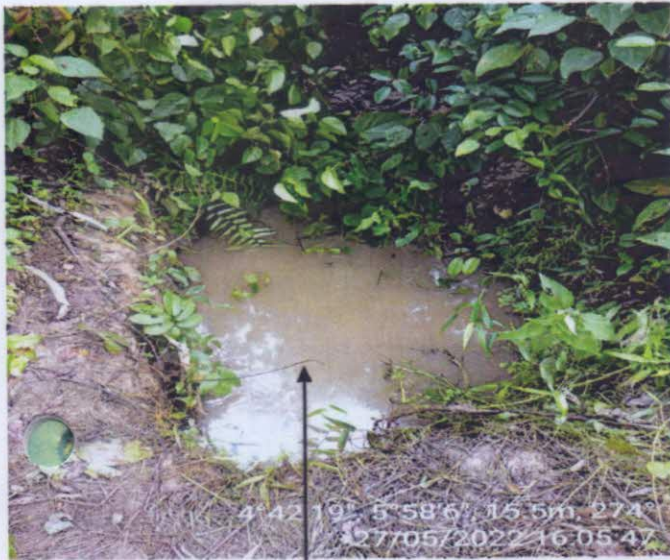
**SPILL POINT** (*Before excavation*)

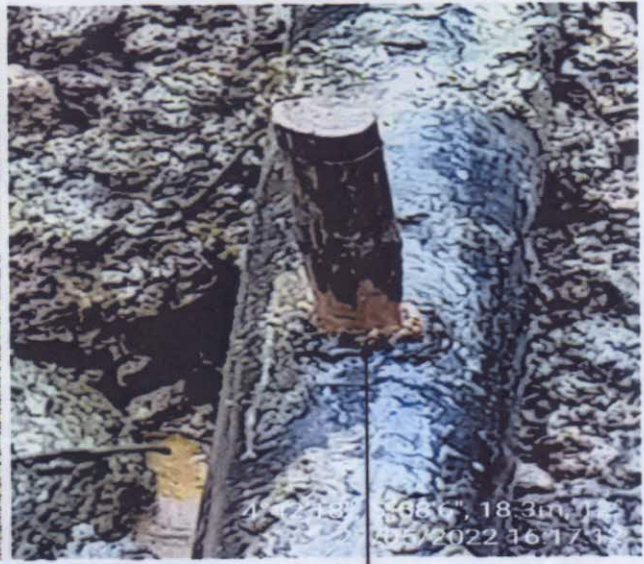
**SPILL POINT** (*After excavation: Installed 2" ball valve  
At 12 O'clock position on the pipeline*)

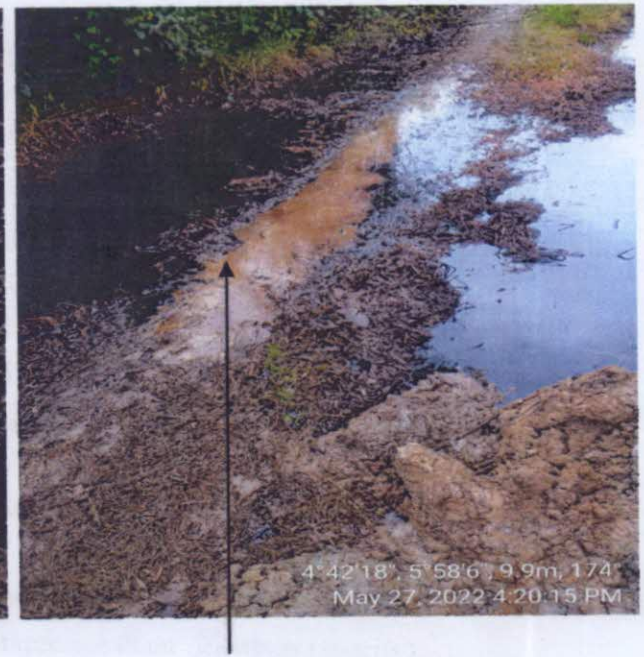
**IMPACTED AREA**
