APPENDIX A:  
 PHOTOGRAPHS TAKEN DURING JIV AT 14" OGBOINBIRI/TEBIDABA PIPELIE AT IKEINGHENBIRI IN  
 SOUTHERN IJAW LOCAL GOVERNMENT AREA OF BAYELSA STATE

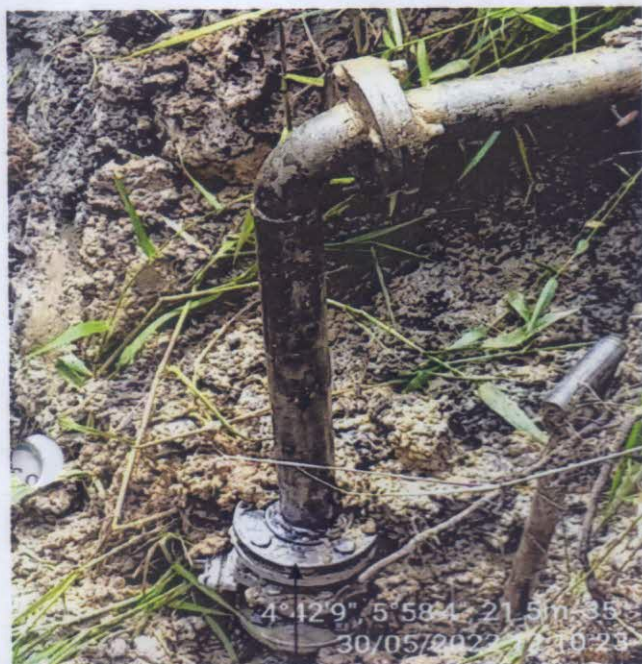
**SPILL POINT** (*Before excavation*)

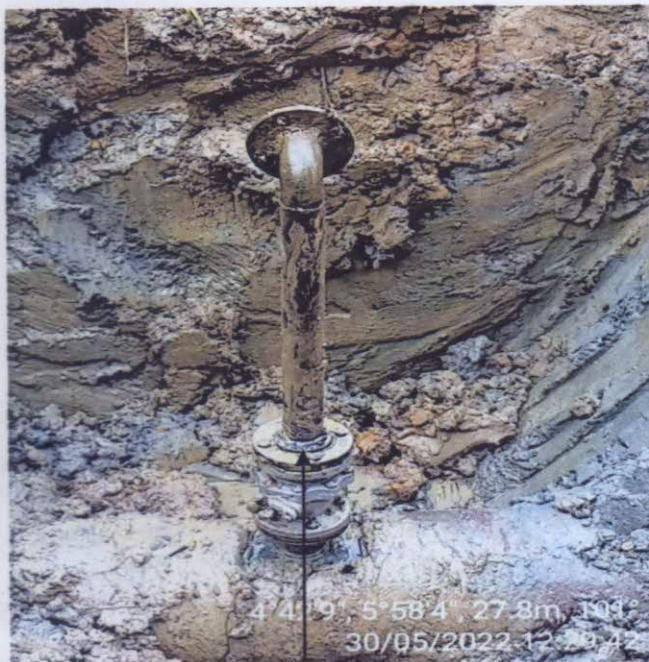
**SPILL POINT** (*After excavation: Installed 3" ball valve  
 At 12 O'clock position on the pipeline*)

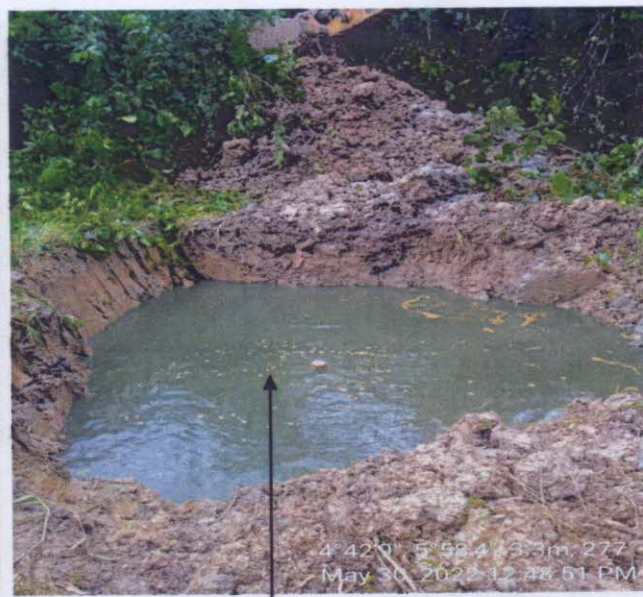
**IMPACTED AREA**
