**APPENDIX A:**

**PHOTOGRAPHS TAKEN DURING JIV AT 14" OGBOINBIRI/TEBIDABA PIPELINE AT IKEINGHENBIRI IN SOUTHERN IJAW LOCAL GOVERNMENT AREA OF BAYELSA STATE**

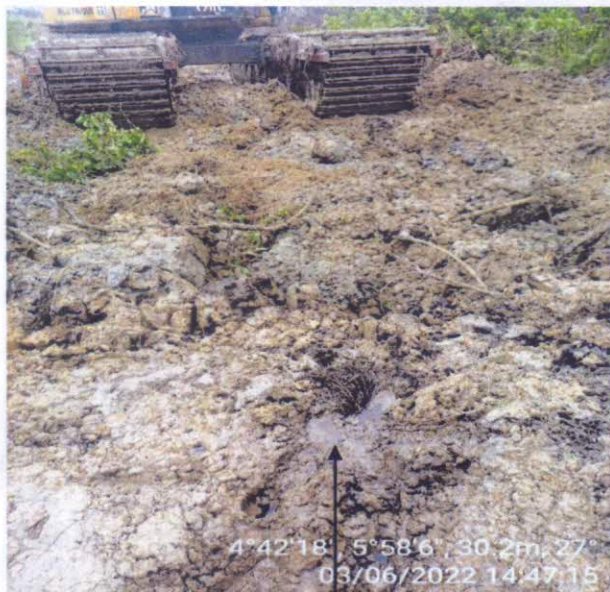
**SPILL POINT** (Before excavation)

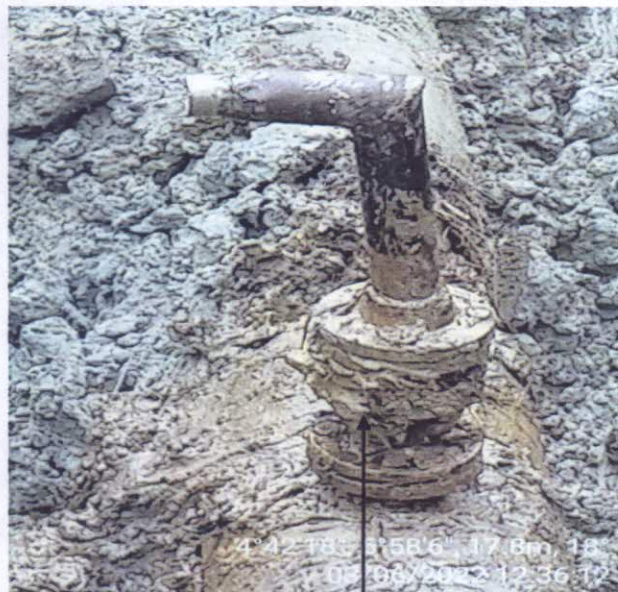
**SPILL POINT** (After excavation: Installed 3" ball valve  
At 12 O'clock position on the pipeline)

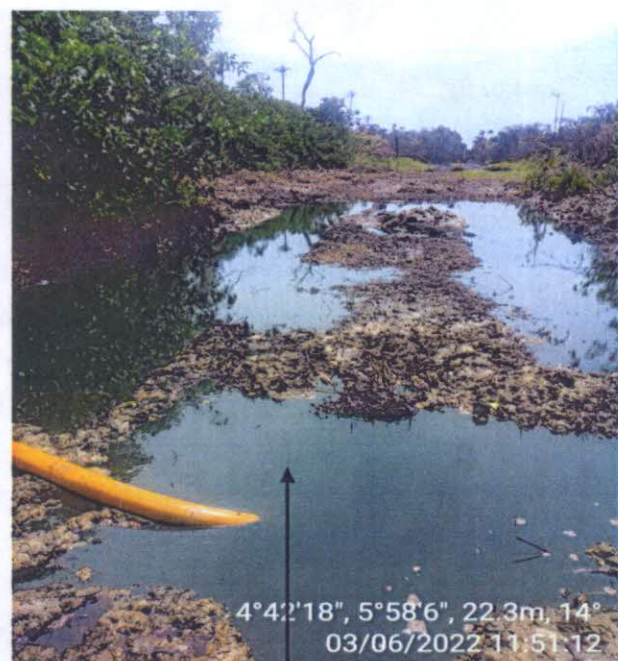
**IMPACTED AREA**
