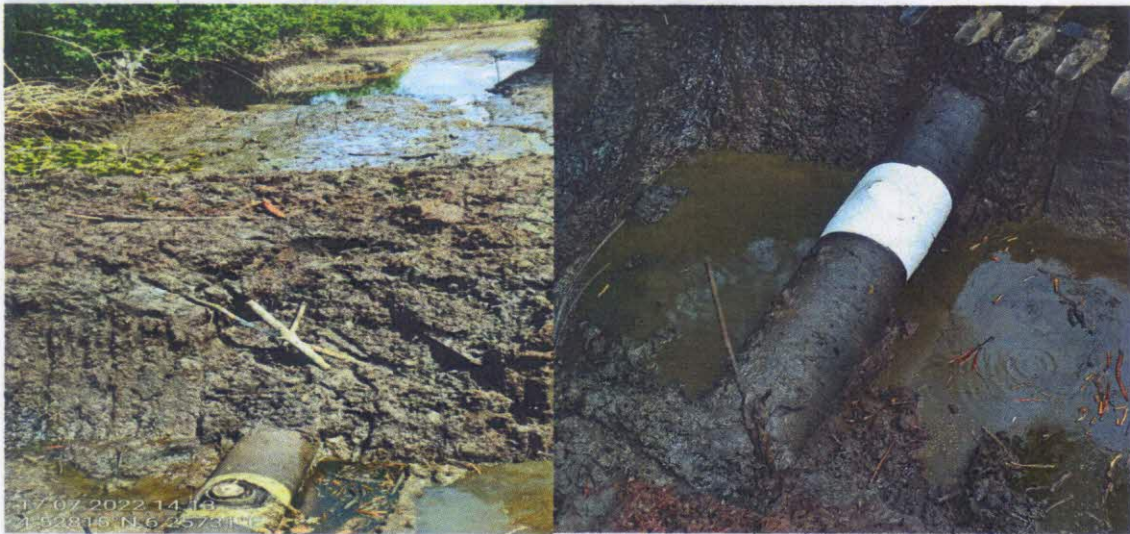
**PICTURE 1: SHOWING THE INCIDENT POINT AT 12 O' CLOCK POSITION OF THE PIPELINE.**

**PICTURE 2: SHOWING THE INCIDENT POINT AFTER REPAIR AND WRAPPING HAS BEEN CARRIED OUT.**

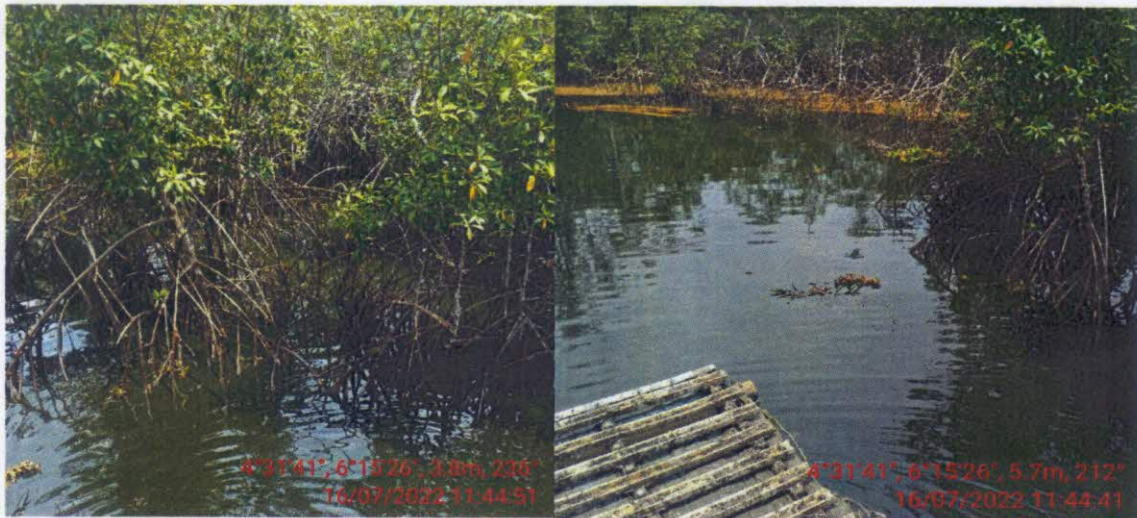
**PICTURE 3: SHOWING MANGROVE HEAVILY IMPACTED BY CRUDE OIL.**

**PICTURE 4: SHOWING SURFACE WATER HEAVILY IMPACTED BY OIL.**
