# LOCAL GOVERNMENT AREA, BAYELSA STATE.

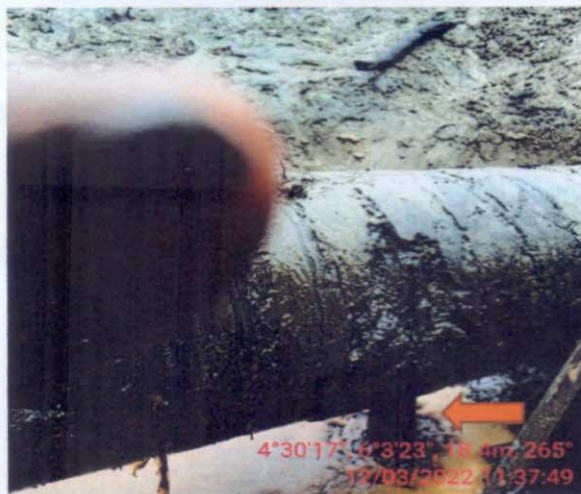
FIG. 1: SHOWING CORROSION POINT AT 6 O' CLOCK POSITION.

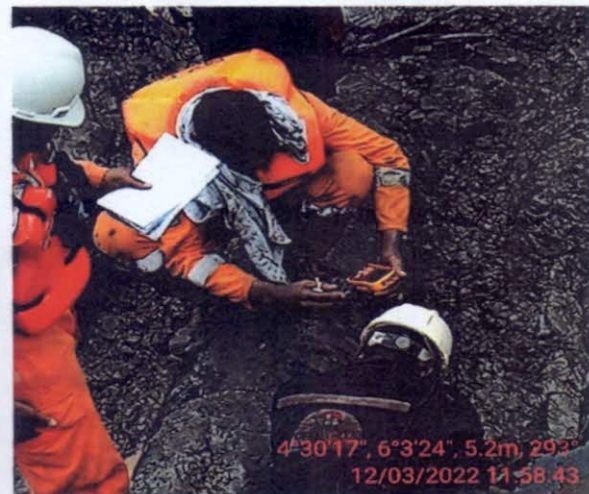
FIG. 1: SHOWING UTM TEST BEING DONE ON THE PIPELINE.

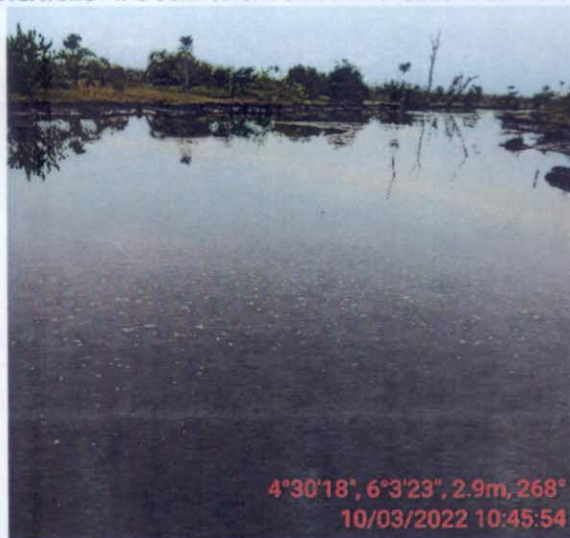
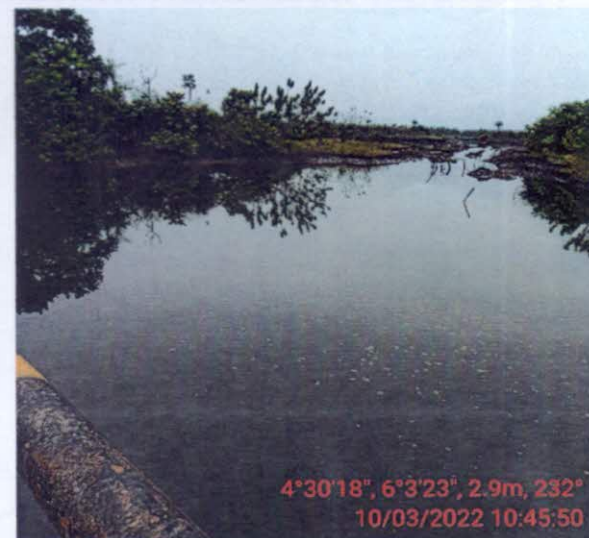
FIG. 3: SHOWING CRUDE OIL ENTERING THE OPEN RIVER. FIG. 4: SHOWING CRUDE OIL IMPACT ON SURFACE WATER AND VEGETATION.
