## APPENDIX I

### SOME PHOTOGRAPHS TAKEN DURING THE JOINT INVESTIGATION VISIT

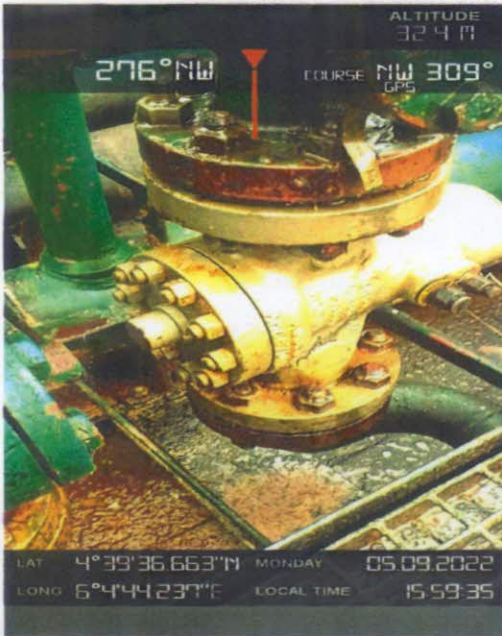
Fig 1: Well 1s Flowline Valve (Incident Valve)

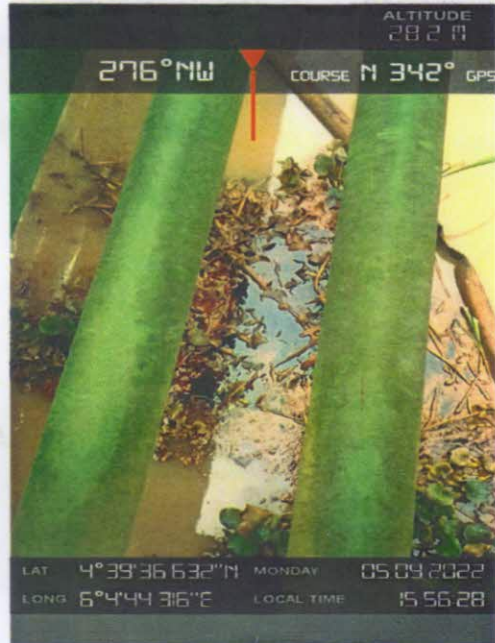
Fig 2: Contained Spill at the Flowstation
