## APPENDIX A

PHOTOGRAPHS TAKEN DURING JIV AT 18"TEBIDABA/BRASS PIPELINE AT ELEPA  
SOUTHERN IJAW LOCAL GOVERNMENT AREA, BAYELSA STATE.

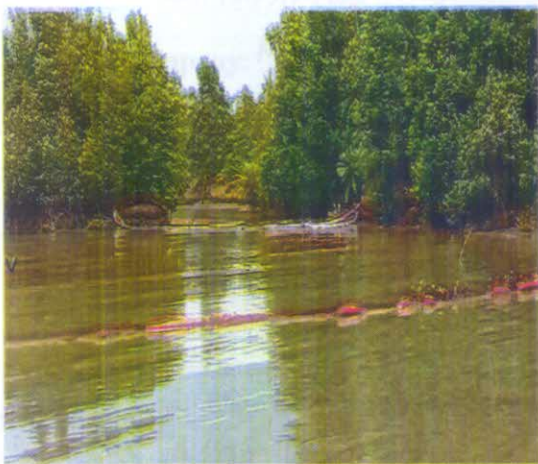
FIG: 1 CONTAINMENT BOOMS

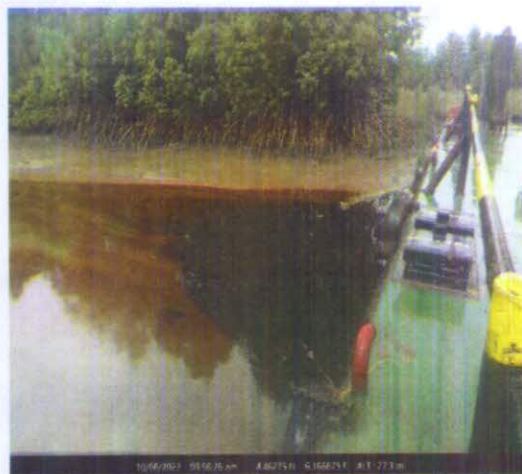
FIG.2 SHOWING SPILLED CRUDE

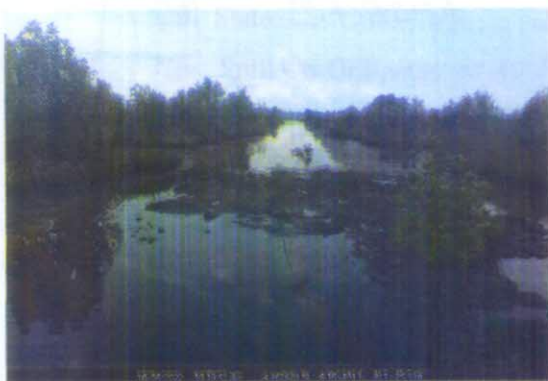
Figure 3 SPILL POINT BEFORE EXCAVATION

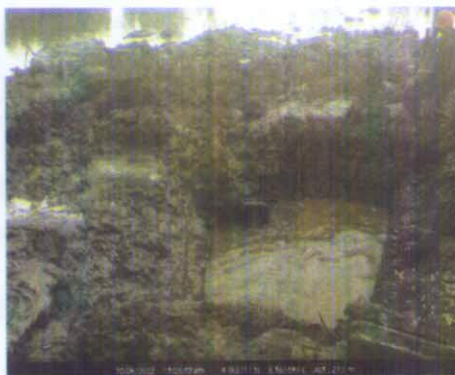
Figure 4 SPILL POINT AFTER EXCAVATION
