## Some Photographs taken during the Joint Investigation Visit (JIV)

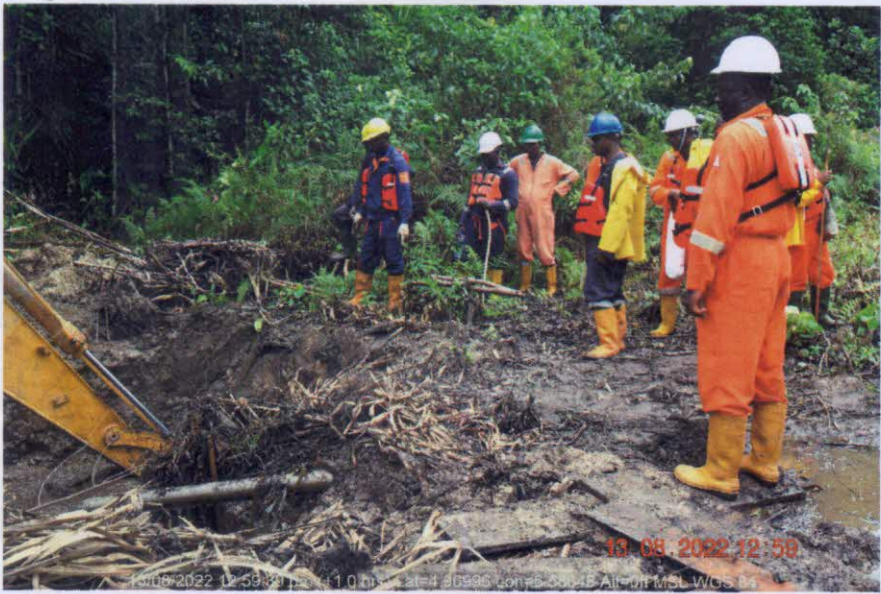
Fig. 1  
Incident Area on Arrival of the JIV

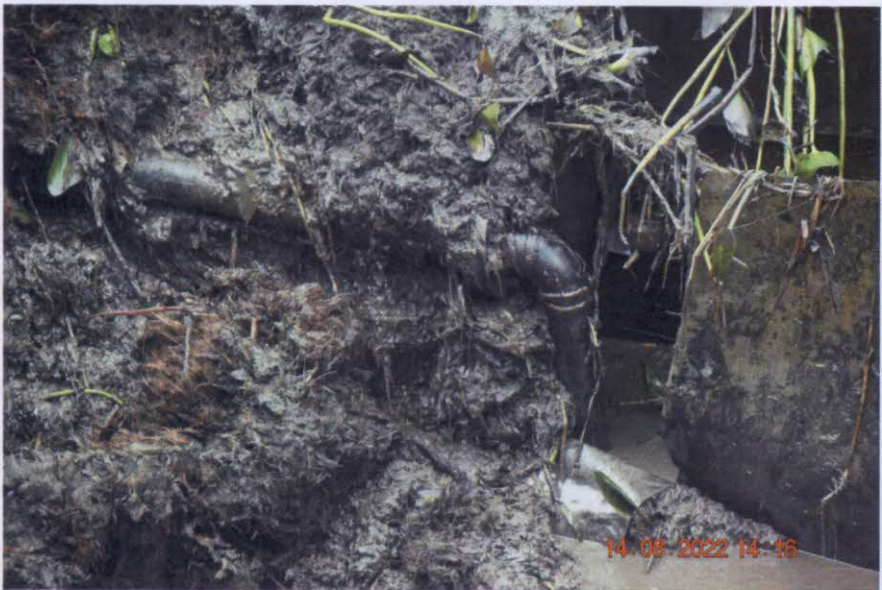
Fig. 2  
Incident Facility Exposure/Impact

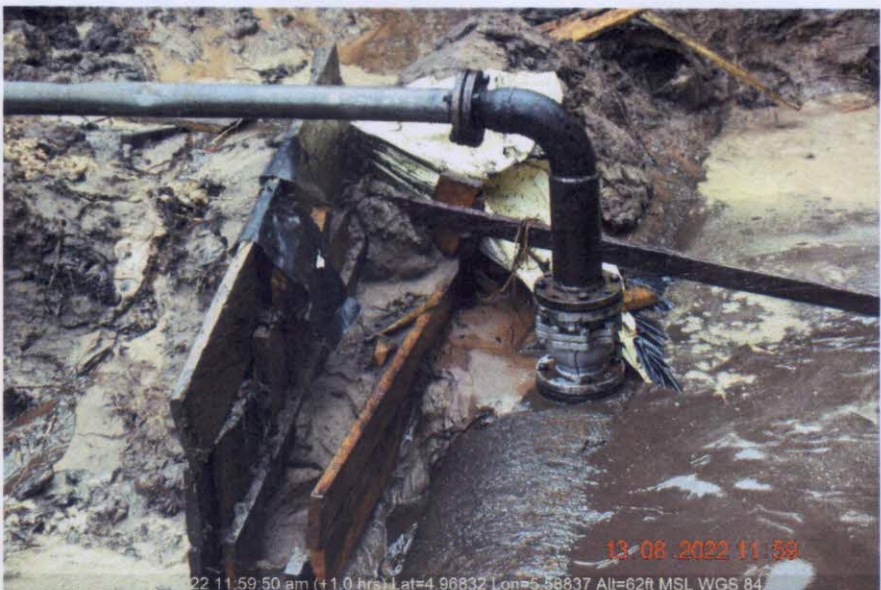
Fig. 3  
The 4" Ball valve attached to the 24" for Oil Theft
