Some Photographs taken during the Joint Investigation Visit (JIV)

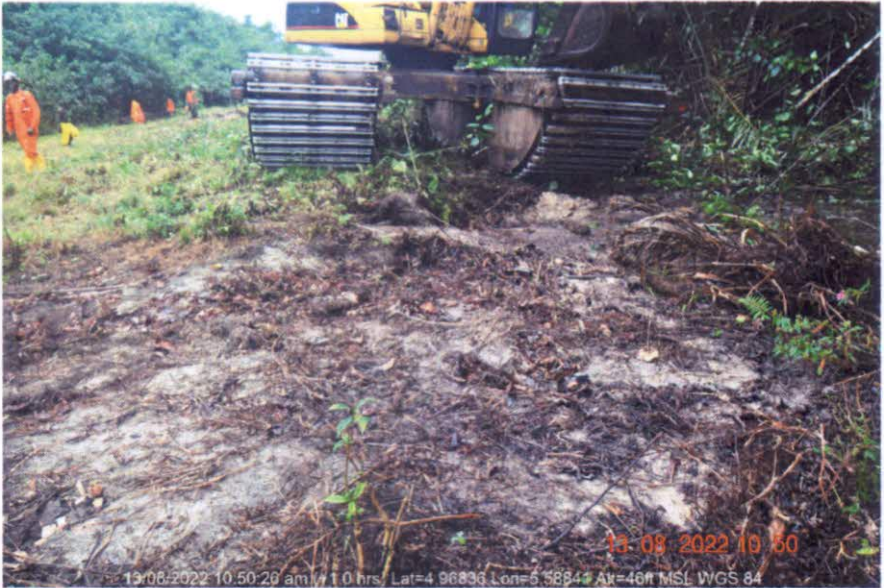
Fig. 1  
Incident Area on Arrival of the JIV

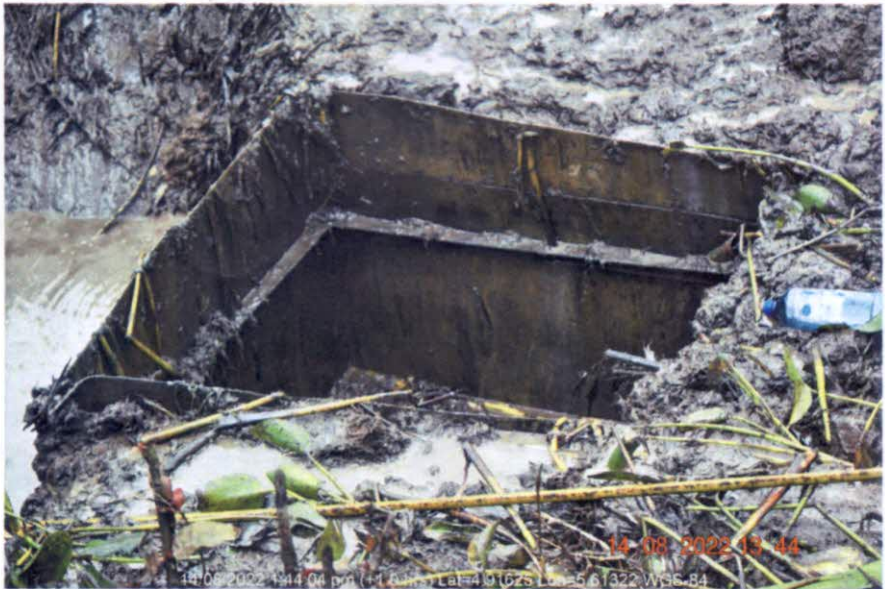
Fig. 2  
Incident Facility Exposure/Impact

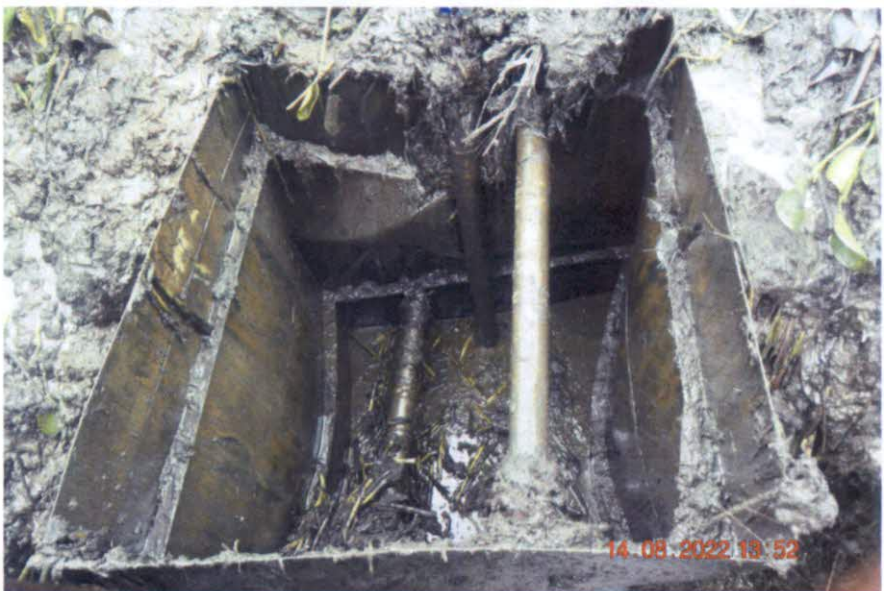
Fig. 3  
The 4" Ball valve attached to the 16" for Oil Theft
