PHOTOGRAPHS TAKEN DURING JIV AT 6" TEBIDABA WELL 14 FLOWLINE AT IKEBIRI IN SOUTHERN IJAW LOCAL GOVERNMENT AREA OF BAYELSA STATE

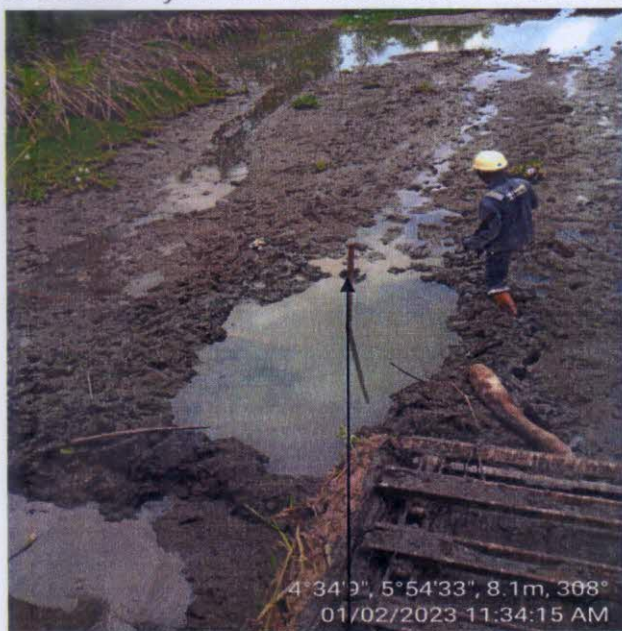
**SPILL POINT BEFORE EXCAVATION**

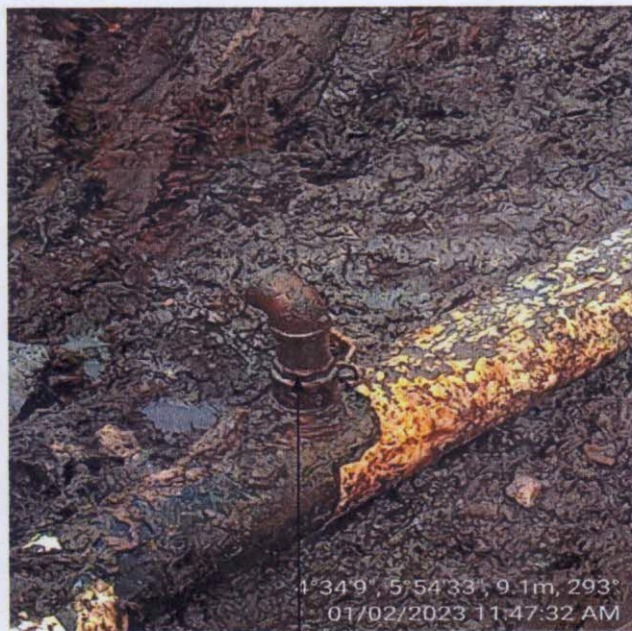
**SPILL POINT**

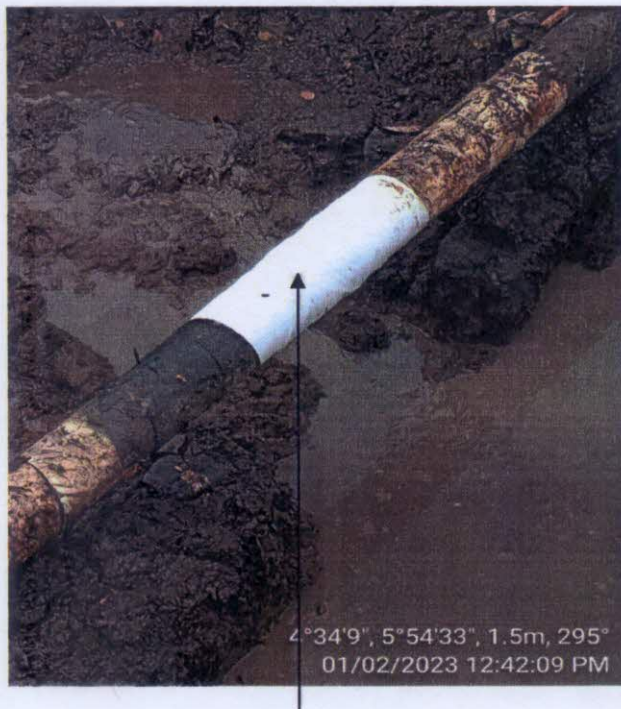
**REPAIR POINT**

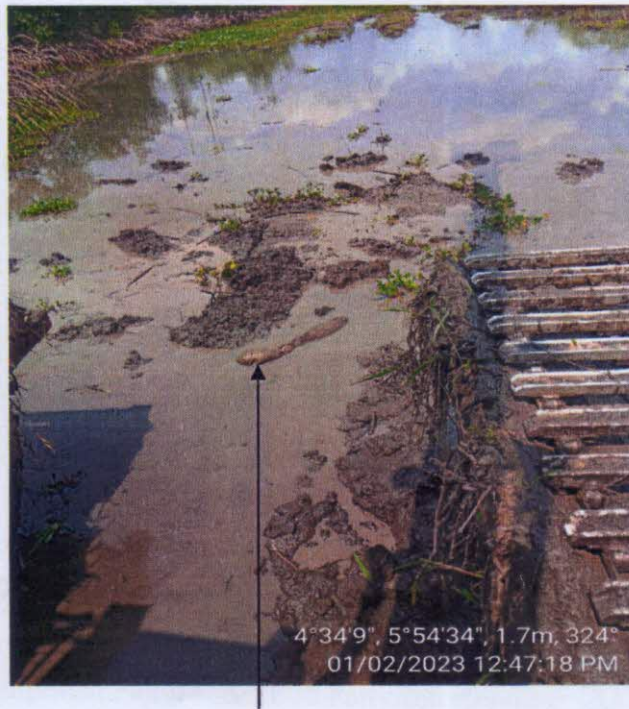
**IMPACTED AREA**
