## APPENDIX A:

PHOTOGRAPHS TAKEN DURING JIV AT 6" AZUZUAMA/TEBIDABA PIPELINE AT IKEBIRI IN SOUTHERN IJAW LOCAL GOVERNMENT AREA OF BAYELSA STATE

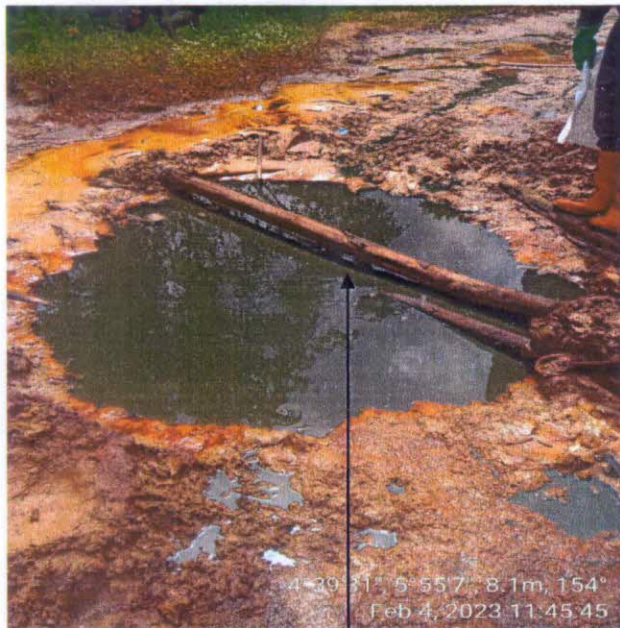
**SPILL POINT BEFORE EXCAVATION**

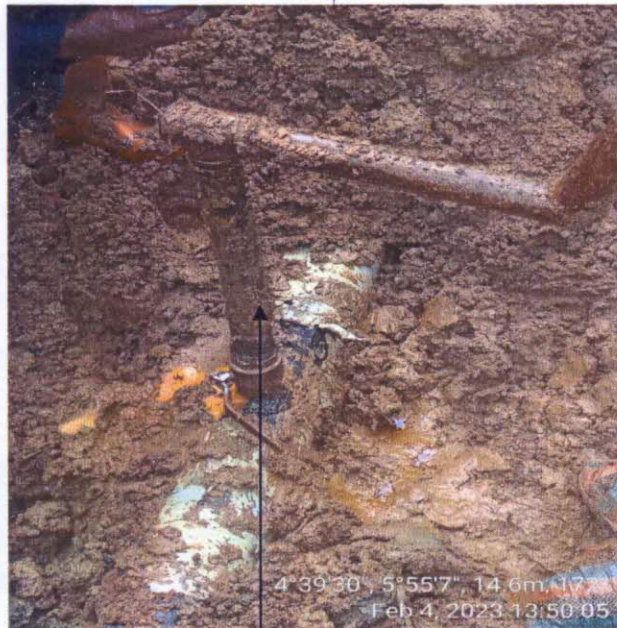
**SPILL POINT**

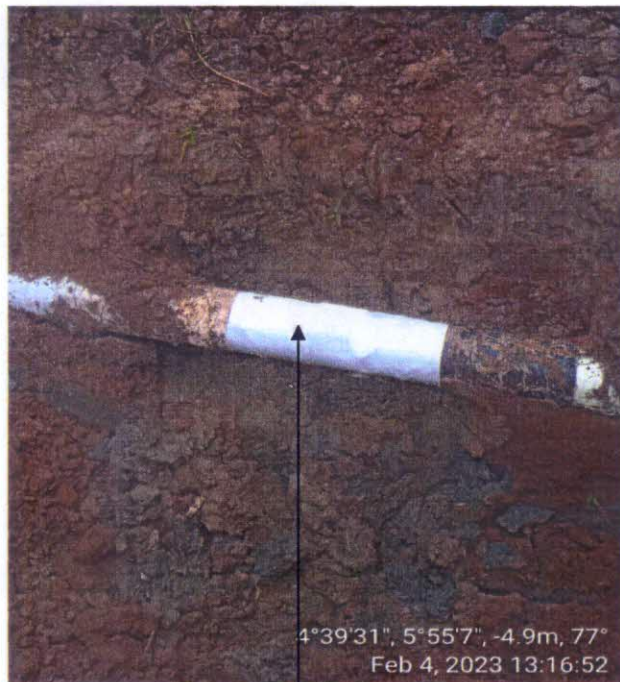
**REPAIR POINT**

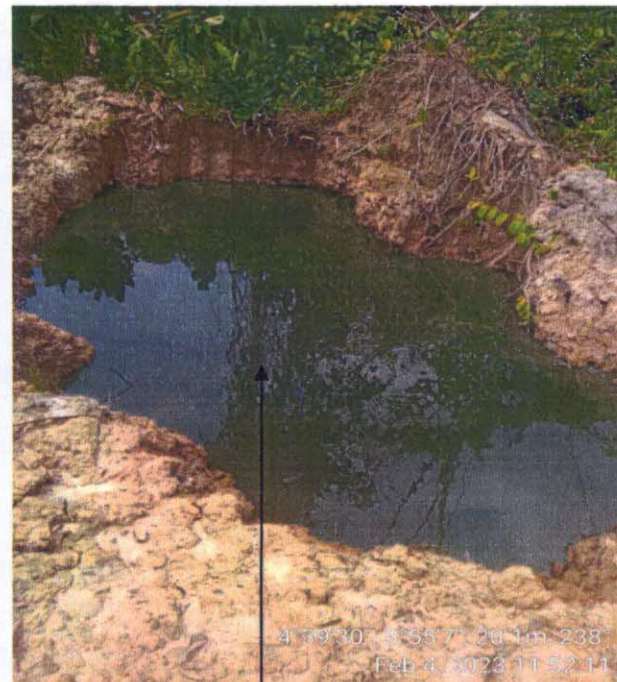
**IMPACTED AREA**
