## APPENDIX A:

PHOTOGRAPHS TAKEN DURING JIV AT 14" OGBOINBIRI/TEBIDABA PIPELINE AT KEME-EBIAMA  
IN SOUTHERN IJAW LOCAL GOVERNMENT AREA OF BAYELSA STATE

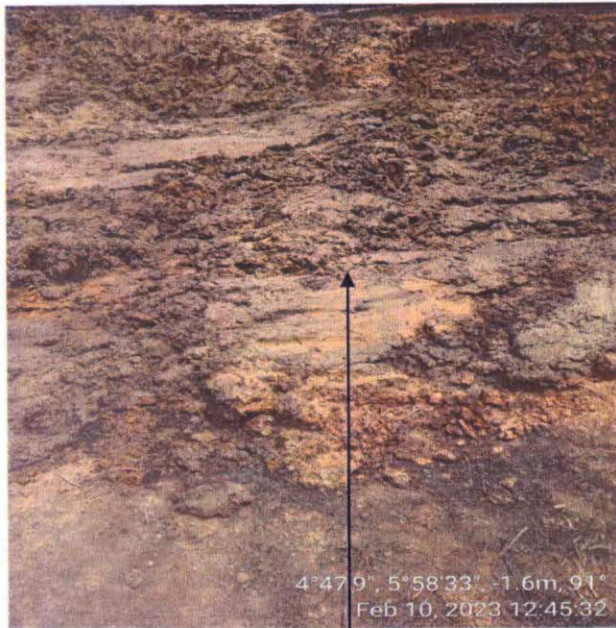
**SPILL POINT BEFORE EXCAVATION**

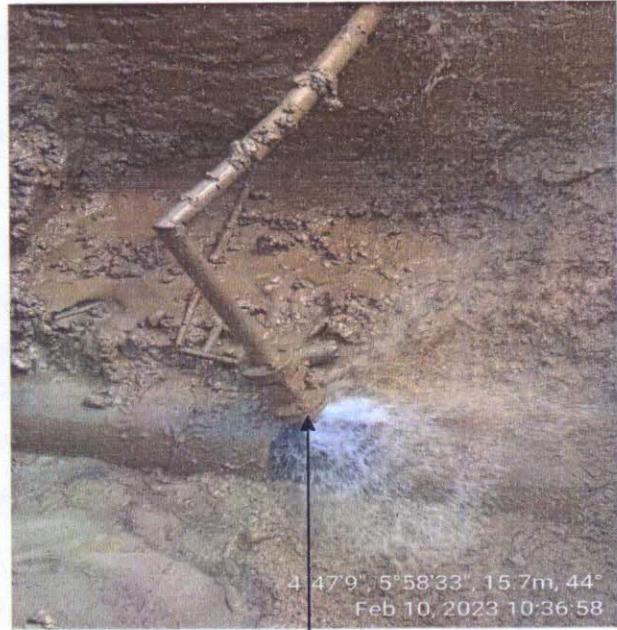
**SPILL POINT**

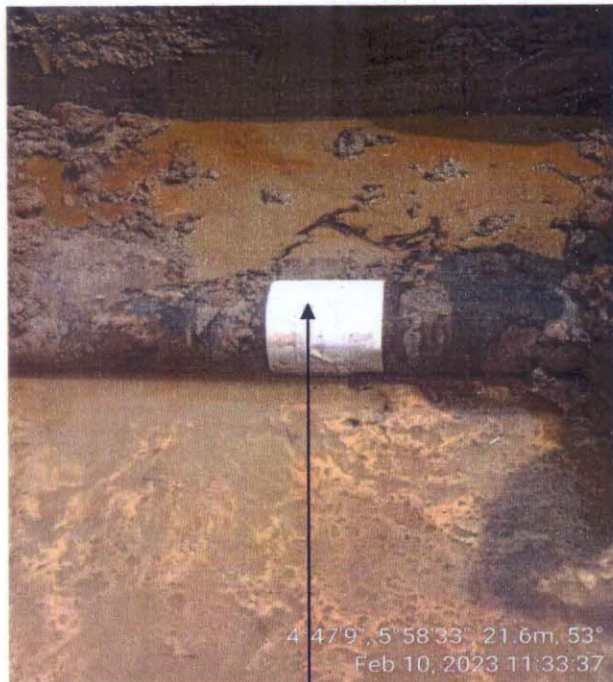
**REPAIR POINT**

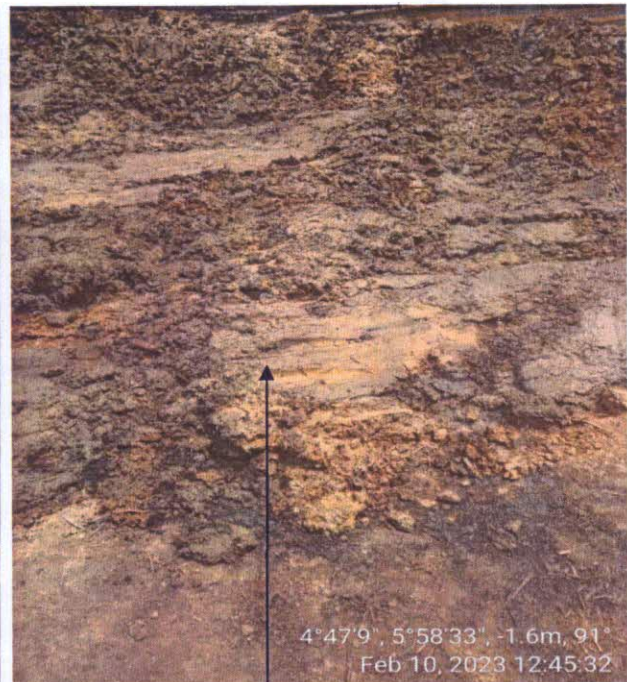
**IMPACTED AREA**
