PHOTOGRAPHS TAKEN DURING JIV AT 14" OGBOINBIRI/TEBIDABA PIPELINE AT KEME-EBIAMA  
IN SOUTHERN IJAW LOCAL GOVERNMENT AREA OF BAYELSA STATE

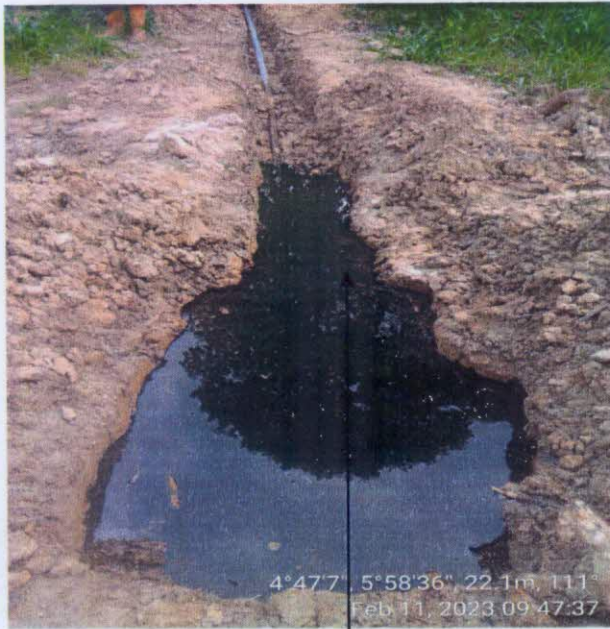
**SPILL POINT BEFORE EXCAVATION**

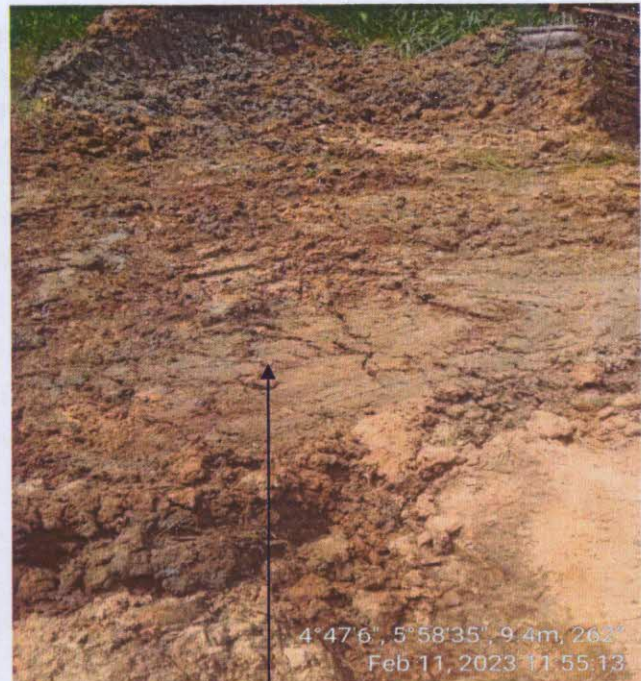
**IMPACTED AREA**
