## APPENDIX A:

PHOTOGRAPHS TAKEN DURING JIV AT 6" OGBOINBIRI/TEBIDABA PIPELINE AT KEME-EBIAMA IN SOUTHERN IJAW LOCAL GOVERNMENT AREA OF BAYELSA STATE

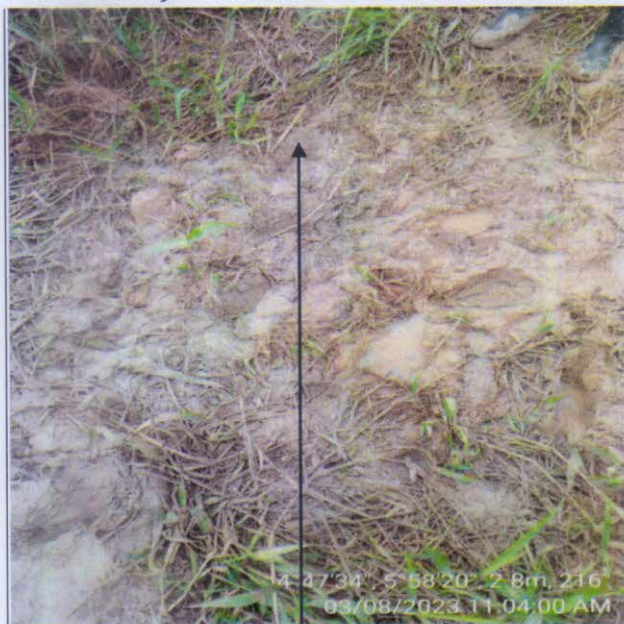
**SPILL POINT BEFORE EXCAVATION**

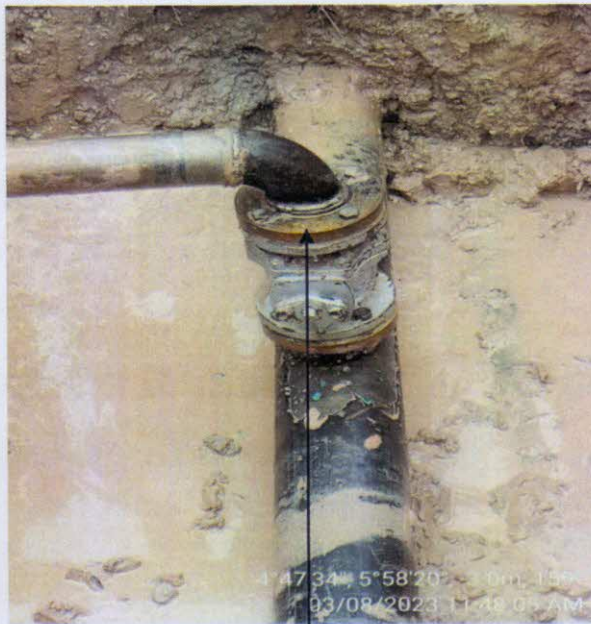
**SPILL POINT**

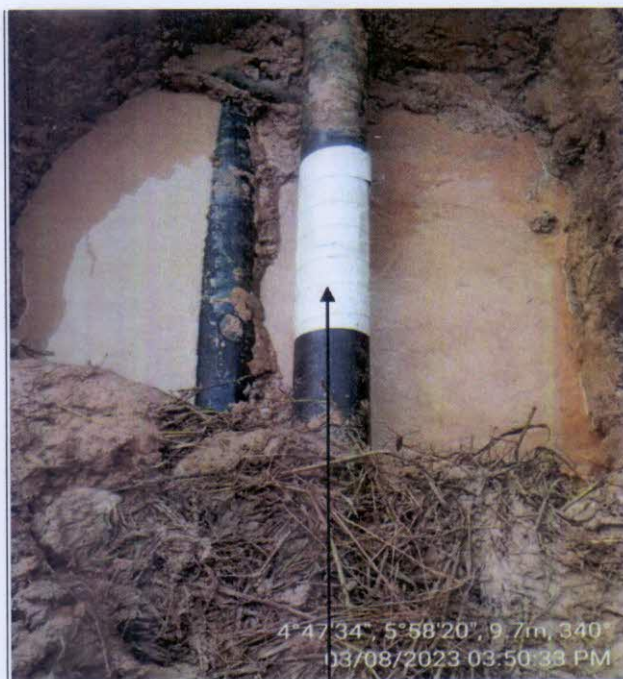
**REPAIR POINT**

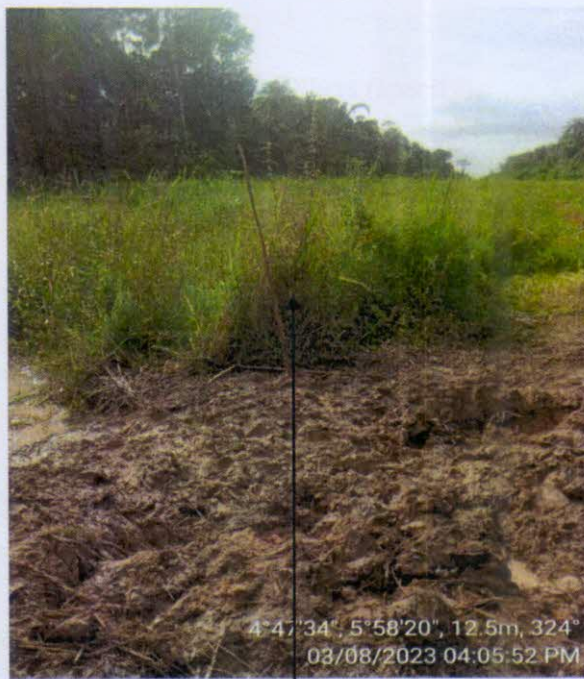
**IMPACTED AREA**
