PHOTOGRAPHS TAKEN DURING JIV AT 6" OGBOINBIRI/TEBIDABA PIPELINE AT KEME-EBIAMA IN SOUTHERN IJAW LOCAL GOVERNMENT AREA OF BAYELSA STATE

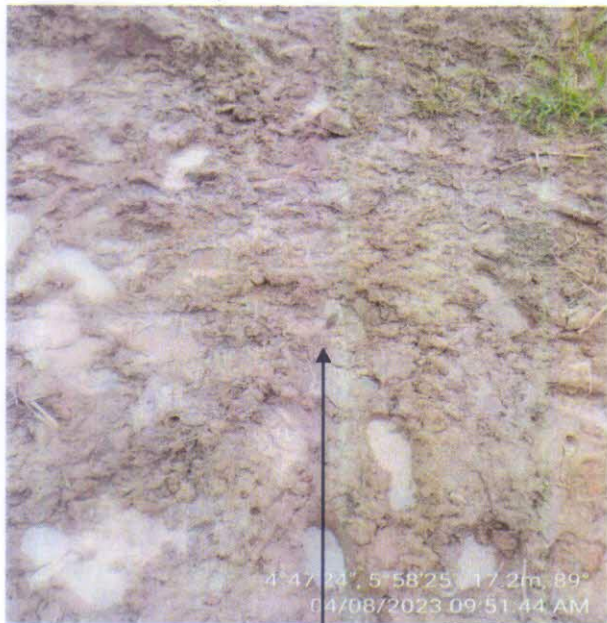
**SPILL POINT BEFORE EXCAVATION**

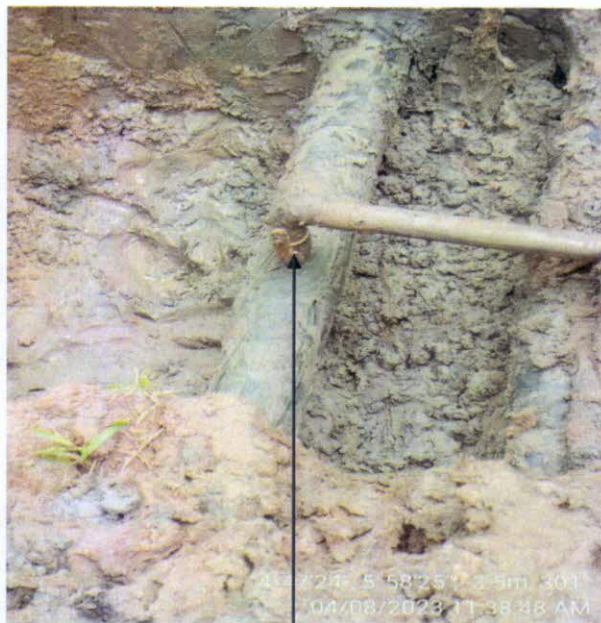
**SPILL POINT**

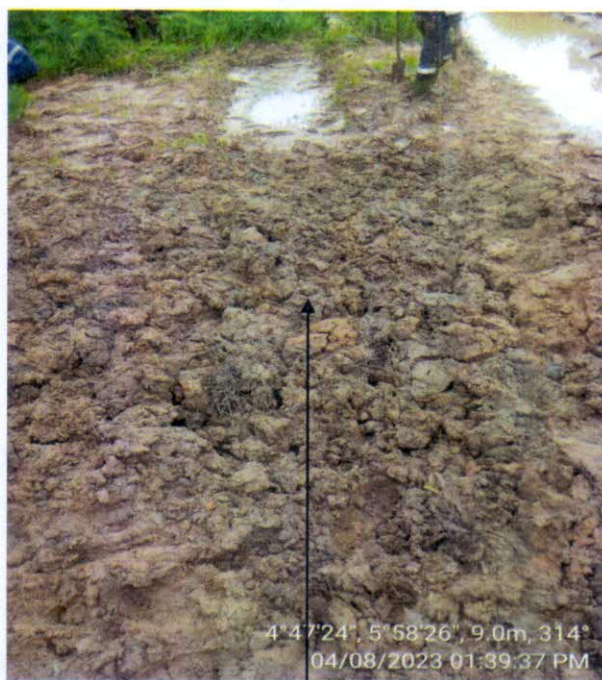
**IMPACTED AREA**
