## APPENDIX A

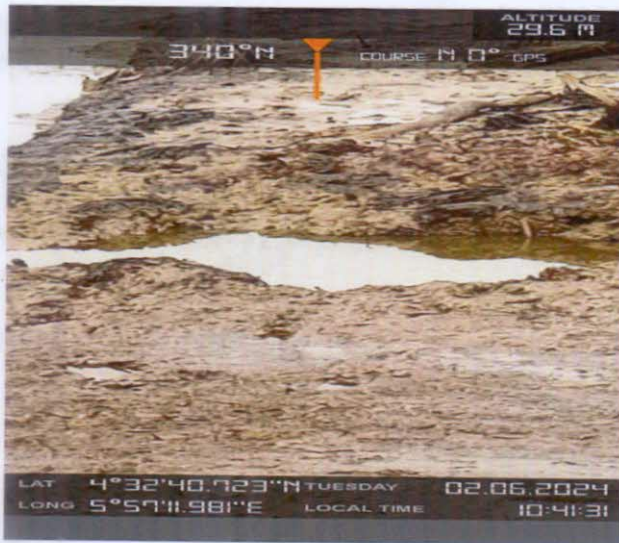
On arrival at the incident point.
