## APPENDIX A

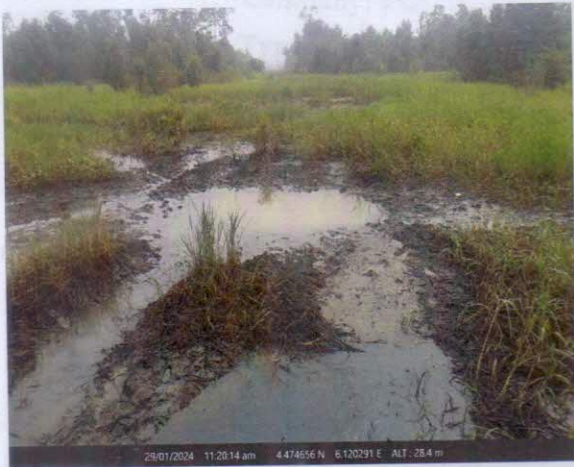
On arrival at the incident point
