## APPENDIX A

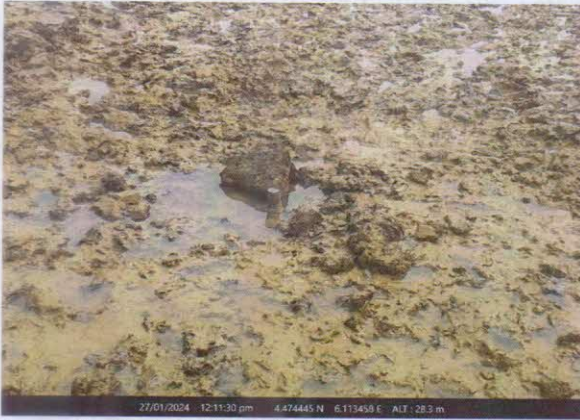
**On arrival at the incident point**
