PICTORIAL REPORT OF JOINT INVESTIGATION VISIT (JIV) TO SK BRIGHT FILLING STATION AT ARAROMI STREET, AKURE SOUTH LOCAL GOVERNMENT AREA OF ONDO STATE, HELD ON TUESDAY JULY 23, 2024.

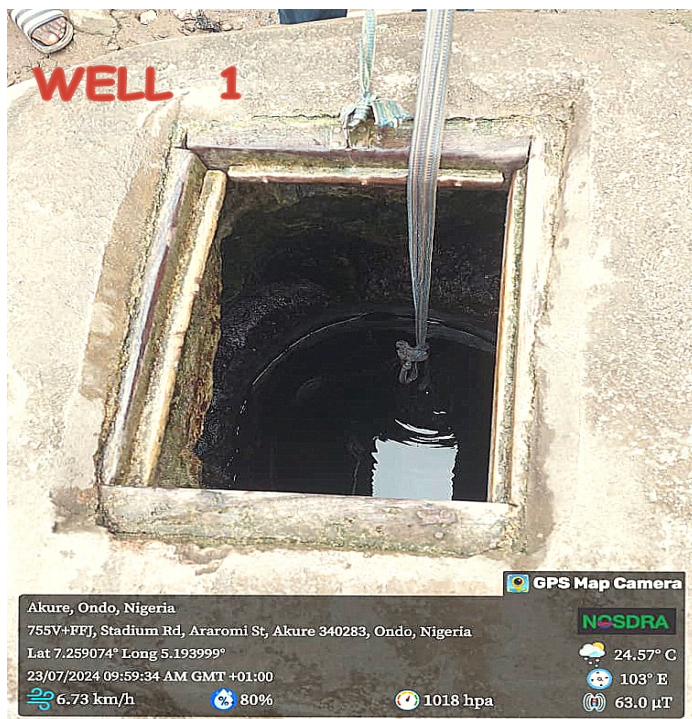
Fig 1: Well-1 appears visibly unpolluted with hydrocarbon.

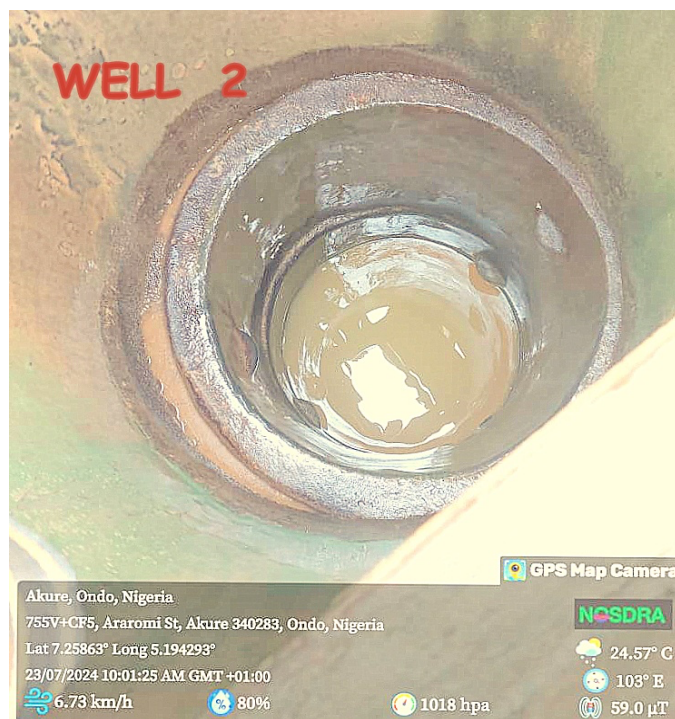
Fig 2: Well-2 appears visibly not contaminated with hydrocarbon.

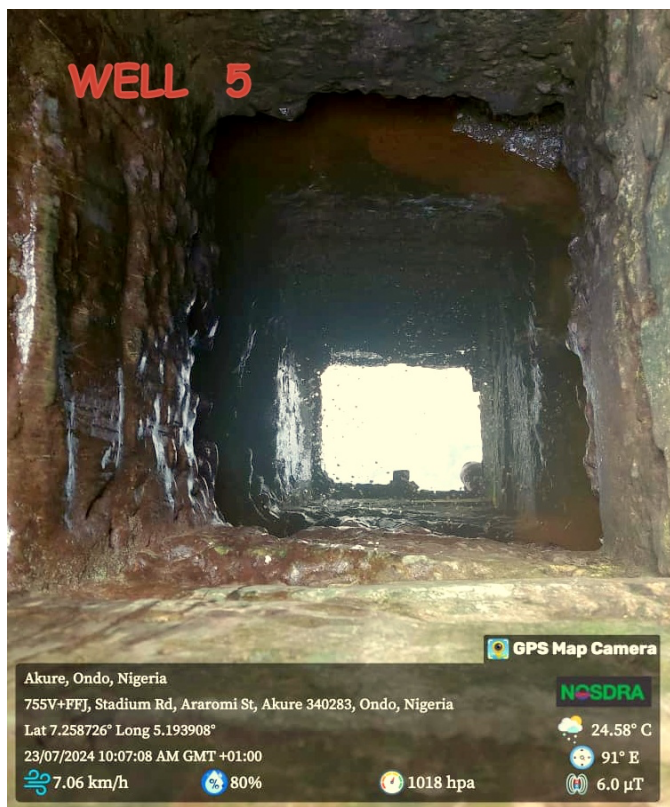
Fig 3: Well-5 suspected to be polluted with PMS.

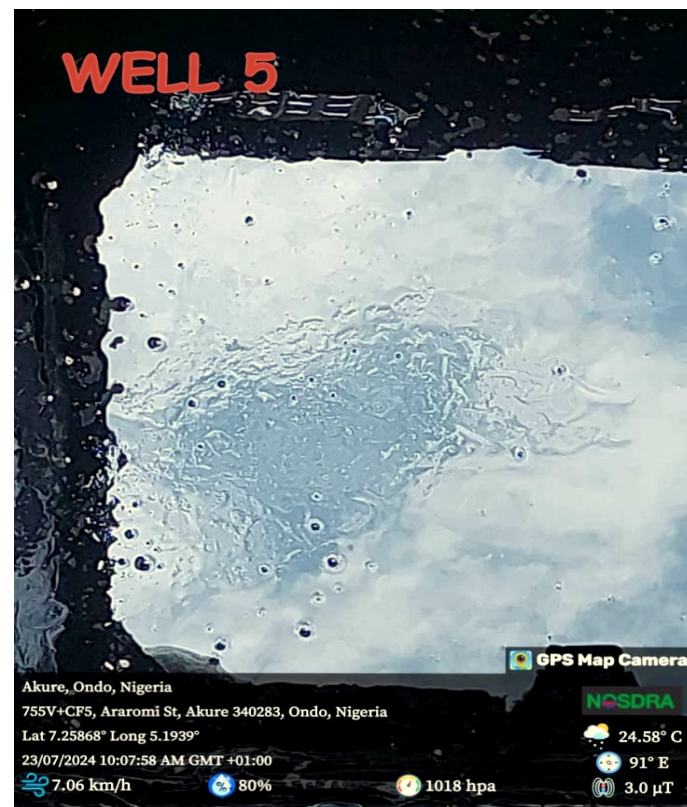
Fig 4: Well-5 at a closer view

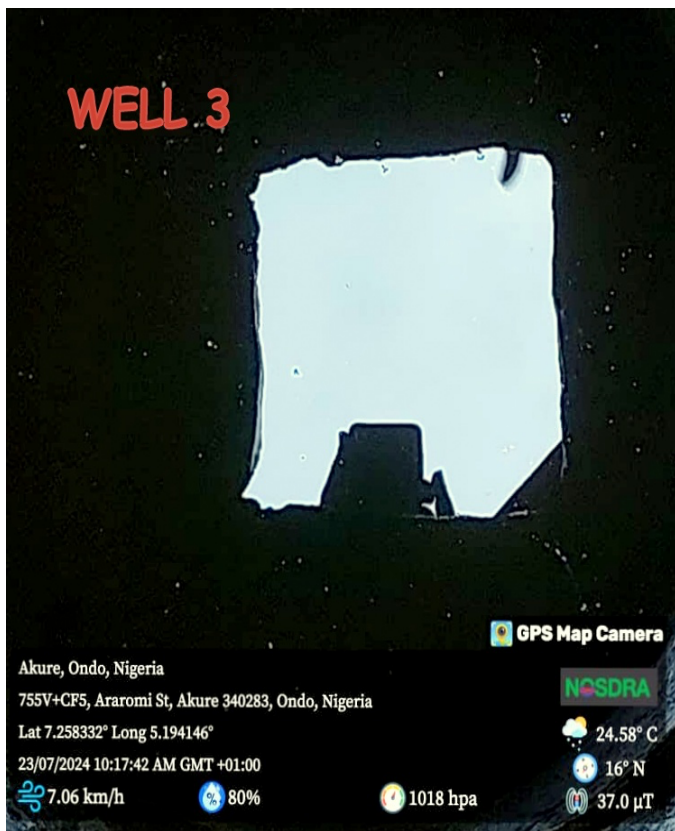
Fig 5: Well 3 appears not physically contaminated.

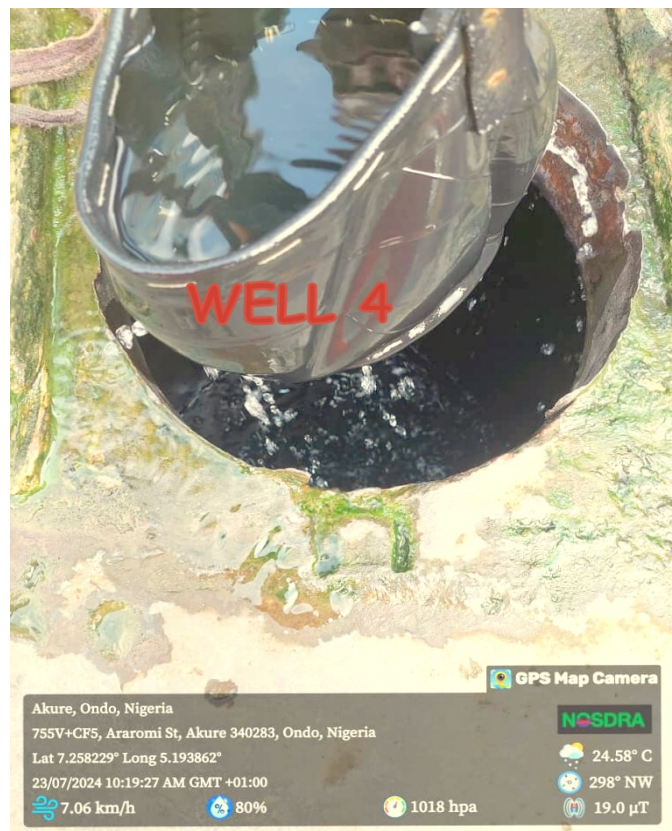
Fig 6: Well 4 looks physically unpolluted

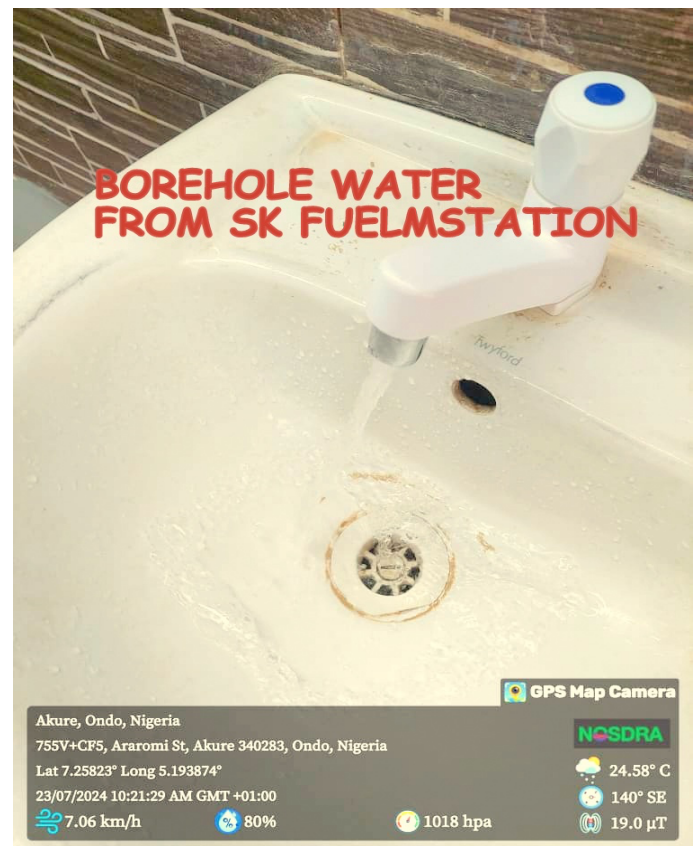
Fig 8: physically clean from SK Fuel Station

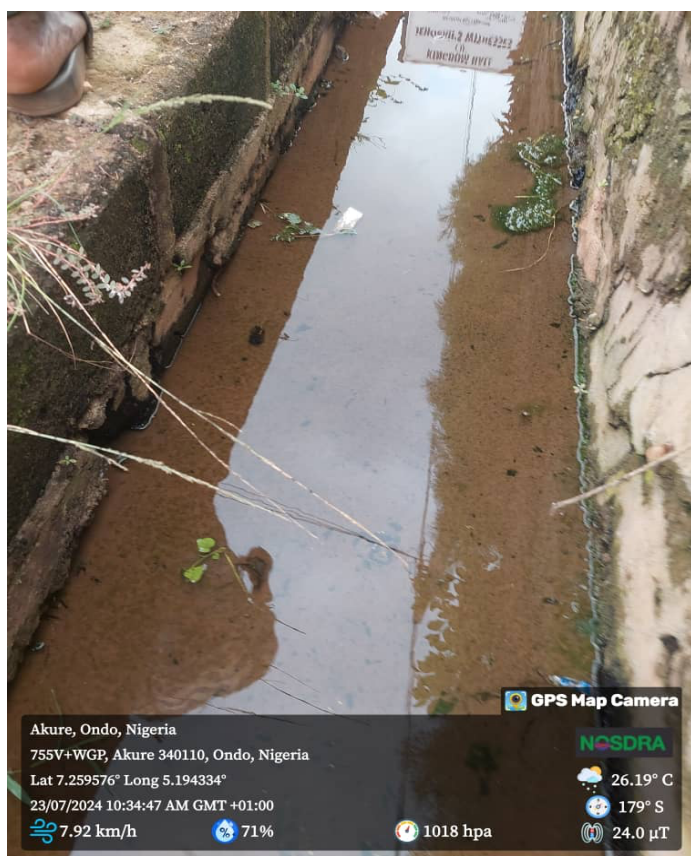
Fig 10: Drainage channel free of sheen
