## 20. Photographs:

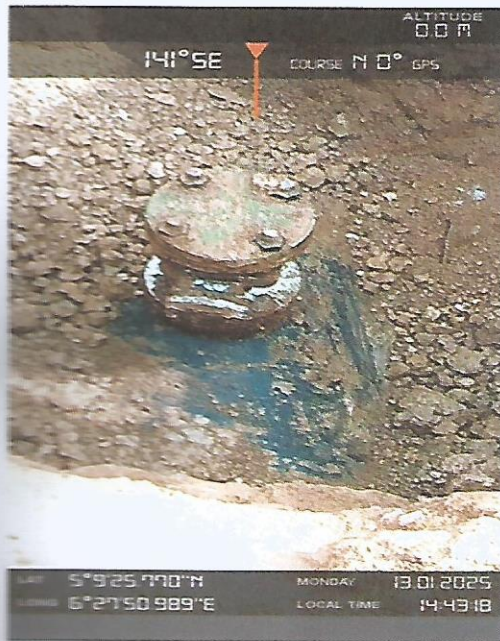
Fig 1. Showing the incident point after excavation.

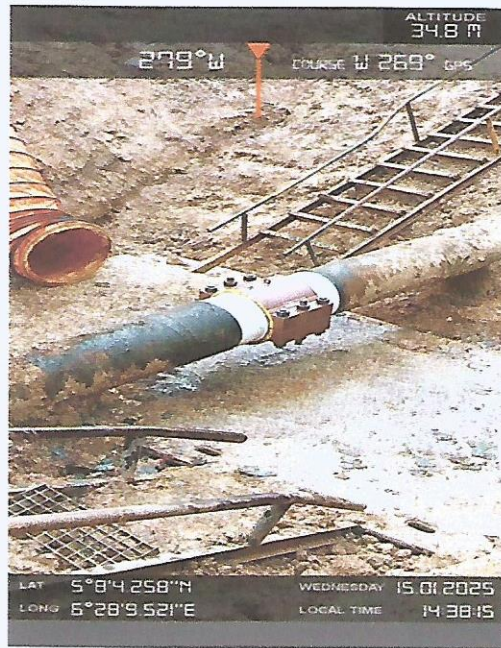
Fig 2. Showing point after repair.
