**NATIONAL OIL SPILL DETECTION AND RESPONSE AGENCY**  
**JOINT INVESTIGATION VISIT (JIV) FORM**

3. Incident Details
  - i. Date of Incident: 01 / 04 / 19    ii. Date first reported: 01 / 04 / 2019
  - iii. Date of first investigation: 02 / 04 / 19    iv. Spill Incident No.: 2019/SAR/NL/006

4. Site Details
  - i. Site/Location: 18" OBAMA/BRASS P/L @ BURMA RICE FARM
  - ii. State: BAYELSA    iii. L.G.A: NEMBE
  - iv. Spill Co-Ordinates: N(m) 04° 34' 04.5"  
E(m) 006° 16' 19.8"

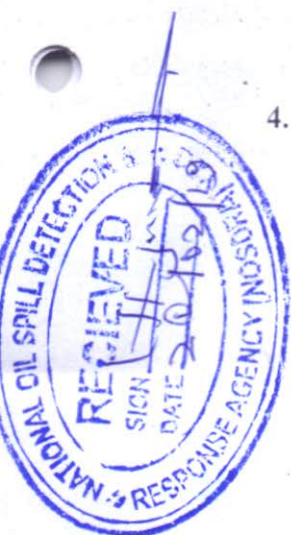
- iv. Cause of Spill  
☐ Corrosion    ☐ Equipment Failure    ☒ Third Party Interference    ☐ Accident  
☐ Operational Error    ☐ Others (specify).....
  - v. Visible Sign of Third Party Interference:  
☒ Hacksaw Marks    ☒ Drilled Holes    ☒ Blasting    ☒ Theft    ☒ Acid  
☒ Others (specify) VANDALS USED A CUTTING MACHINE/DEVICE TO CUT OFF THE TOP OF CONE OF PREVIOUSLY REPAIRED POINT

12. Remarks/Recommendation (i) SECURITY WITHIN AND OUTSIDE

THE ROW SHOULD BE ENHANCED

(u) INCIDENT WAS A NON-LEAK; NO CLEAN-UP REQUIRED.
