**NATIONAL OIL SPILL DETECTION AND RESPONSE AGENCY**  
**JOINT INVESTIGATION VISIT (JIV) FORM**

3. Incident Details  
i. Date of Incident: 07/01/19 ii. Date first reported: 07/01/2019  
iii. Date of first investigation: 11/01/18 iv. Spill Incident No: 2019/LAR/009

4. Site Details  
i. Site/Location: 6" TUOMO-0GBAINBIRI P/L @ LALAGBENE  
ii. State: BAYELSA iii. L.G.A: EKEREMOR  
iv. Spill Co-Ordinates: N(m) 05° 03' 24.7"  
E(m) 005° 55' 04.2"

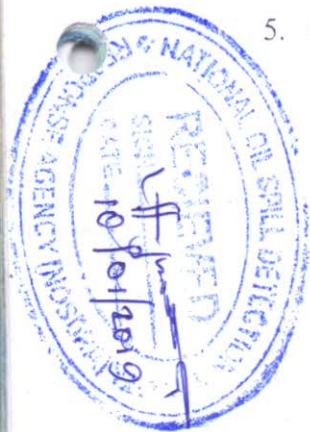
- iv. Cause of Spill  
☒ Corrosion    ☒ Equipment Failure    ☒ Third Party Interference    ☒ Accident  
☒ Operational Error    ☒ Others (specify).....
- v. Visible Sign of Third Party Interference  
☒ Hacksaw Marks    ☒ Drilled Holes    ☒ Blasting    ☒ Theft    ☒ Acid  
☒ Others (specify) ABOUT 500mm TEAR AND DEPRESSION WAS OBSERVED ON THE EXTERNAL SURFACE OF THE P/L  
THE IMPACT IS SUSPECTED TO BE DUE TO USE OF EXPLOSIVES.

12. Remarks/Recommendation (i) CLEAN-UP OF IMPACTED AREA

(ii) IMPROVED SECURITY (iii) COMMUNITY REFUSED TO PARTICIPATE IN THE DELIMITATION SURVEY/SIGNING OF JIV FORM
