## PHOTOGRAPHS TAKEN ON SITE

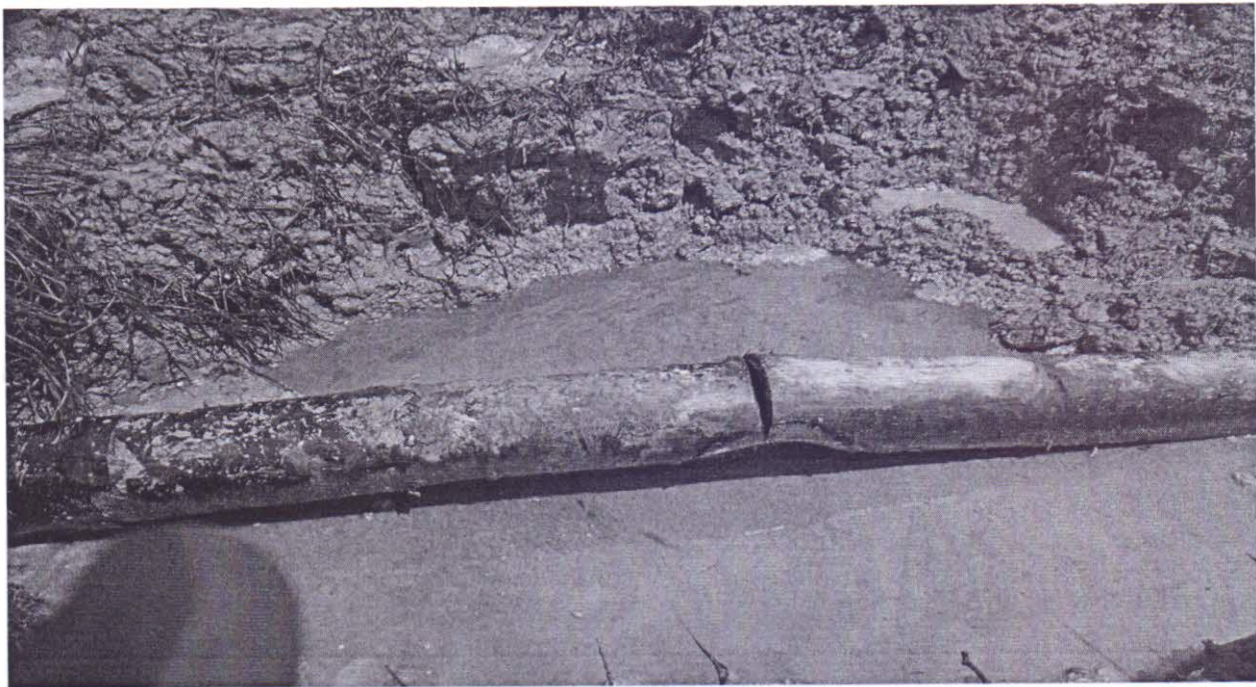
FIG 1: Spill point with blast 6 O clock position and Hack saw cut at 10 O clock to 2 O clock position
