## **Spill Event Summary**

## Technical Explanation

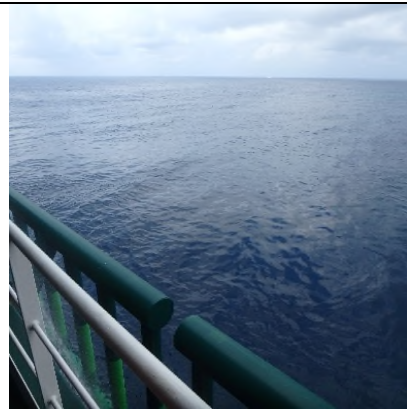
| <b><u>Pictures of 1<sup>st</sup> August 2020 (10:00 AM around EGINA)</u></b> | | |

| <i>Remaining light traces at Egina</i> | <i>Remaining light traces at Egina</i> | <i>No longer sheen at 10NM NE from Akpo</i> |
