**National Oil Spill Detection and Response Agency**  
**JOINT INVESTIGATION VISIT (JIV) FORM**

| Site Organization | | Mandatory Information Required | |
|---|---|---|---|
| Incident Number | | NNPC E&P/002/04-2025 | |
| Facility Address | | 12" LOCATION 2B LP LINE | |

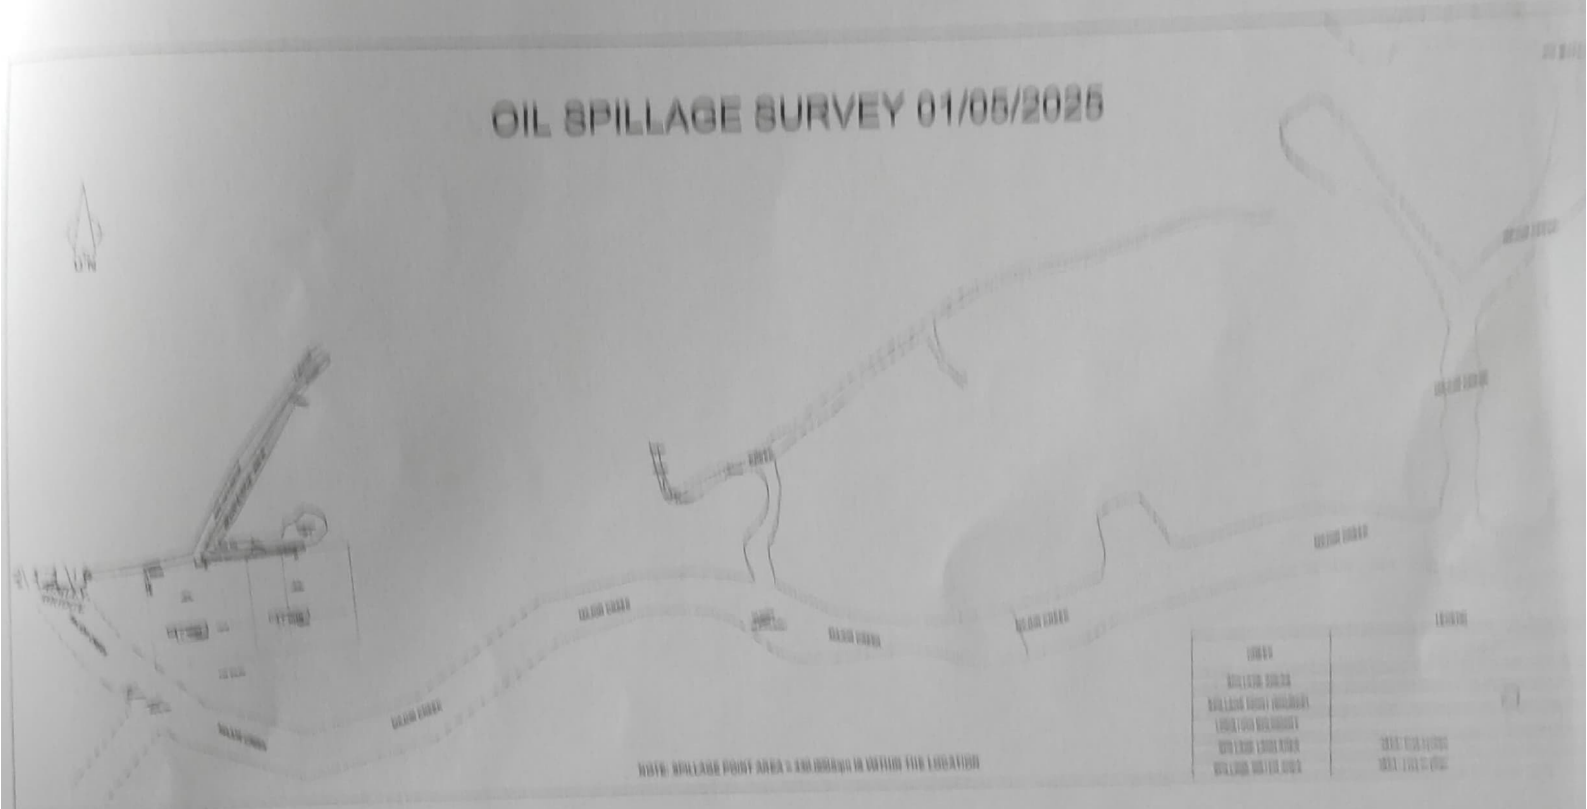
# OIL SPILLAGE SURVEY 01/05/2025

| LEGEND | |
|---|---|
| SPILLAGE WATER AREA | AREA = 430,000sqm |

NOTE: SPILLAGE POINT AREA & SURROUNDING AREA IS NOTED IN LOCATION

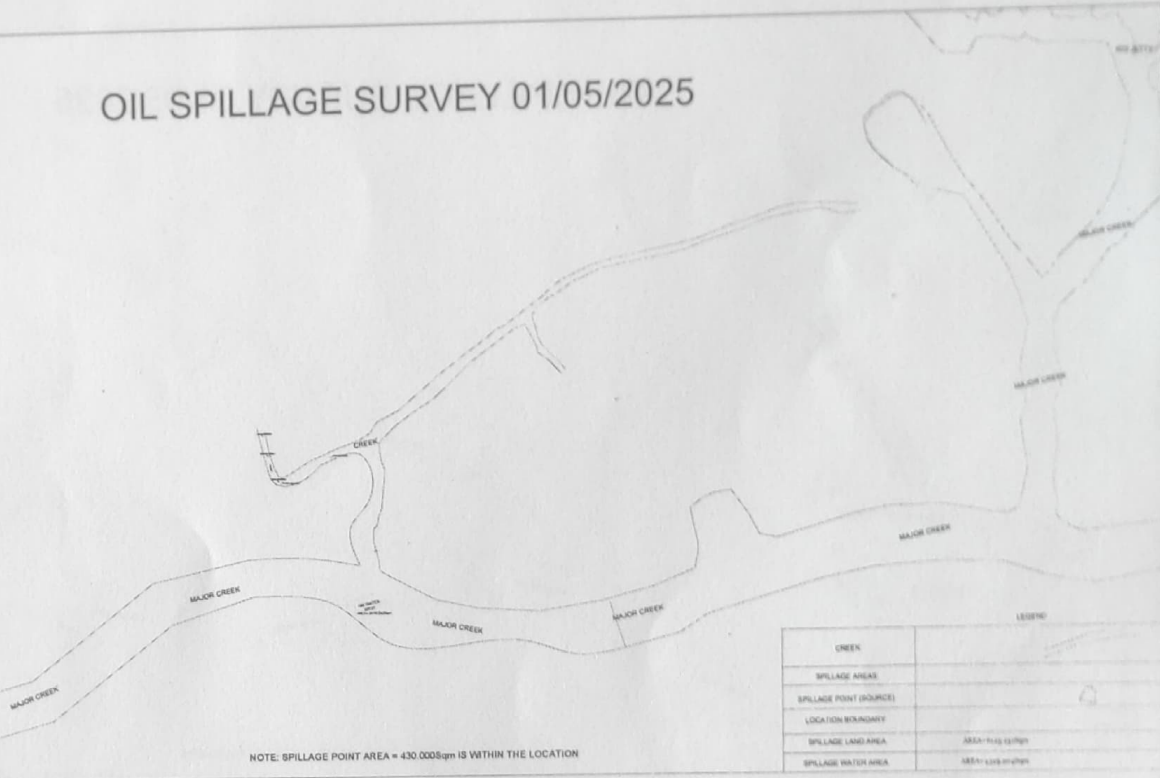
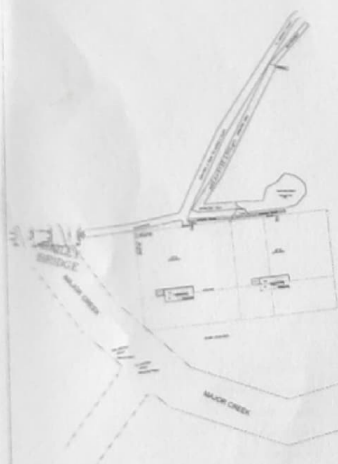
# OIL SPILLAGE SURVEY 01/05/2025

NOTE: SPILLAGE POINT AREA = 430 000sqm IS WITHIN THE LOCATION
