## APPENDIX A

*PHOTOGRAPHS TAKEN DURING JIV AT 4'' Kanbo 3 Lima Right of Way At Abgidiana In Ekeremor Local Government Area Of Bayelsa State*

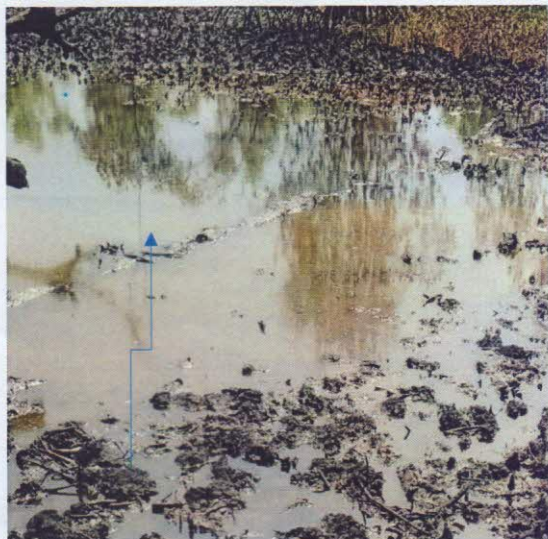
**SPILL POINT AREA (BEFORE EXCAVATION)**

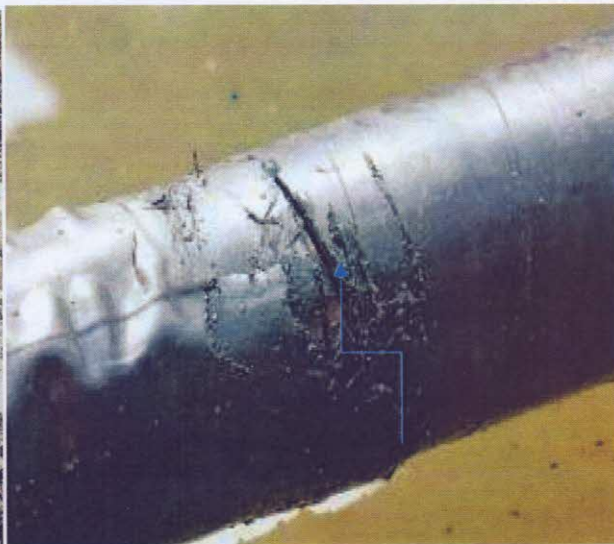
**HACKSAW CUT ON THE FACILITY AT 12 O'CLOCK POSITION (AFTER EXCAVATION)**

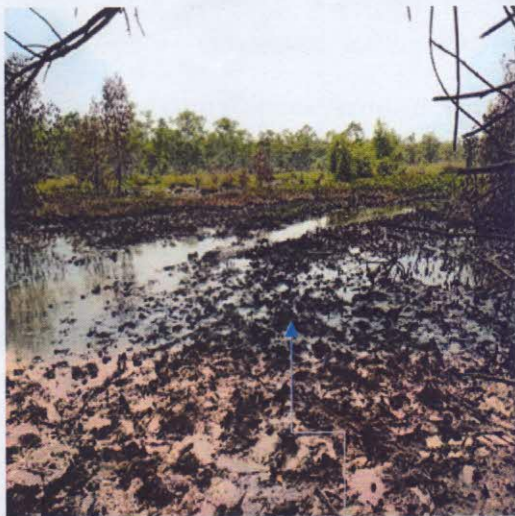
**PART OF THE IMPACTED AREA**

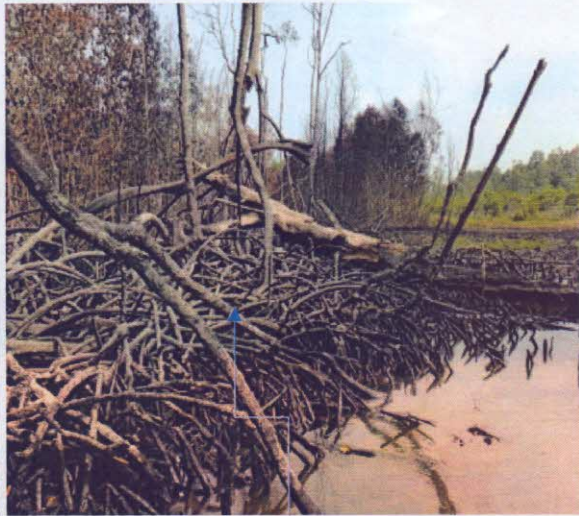
**BURNT VEGETATION AROUND THE SPILL POINT AREA**
