## OVERFLY of SEPCOL FPSO OIL SPILL INCIDENT ON 04/02/2022

### OVERFLIGHT OBSERVATION

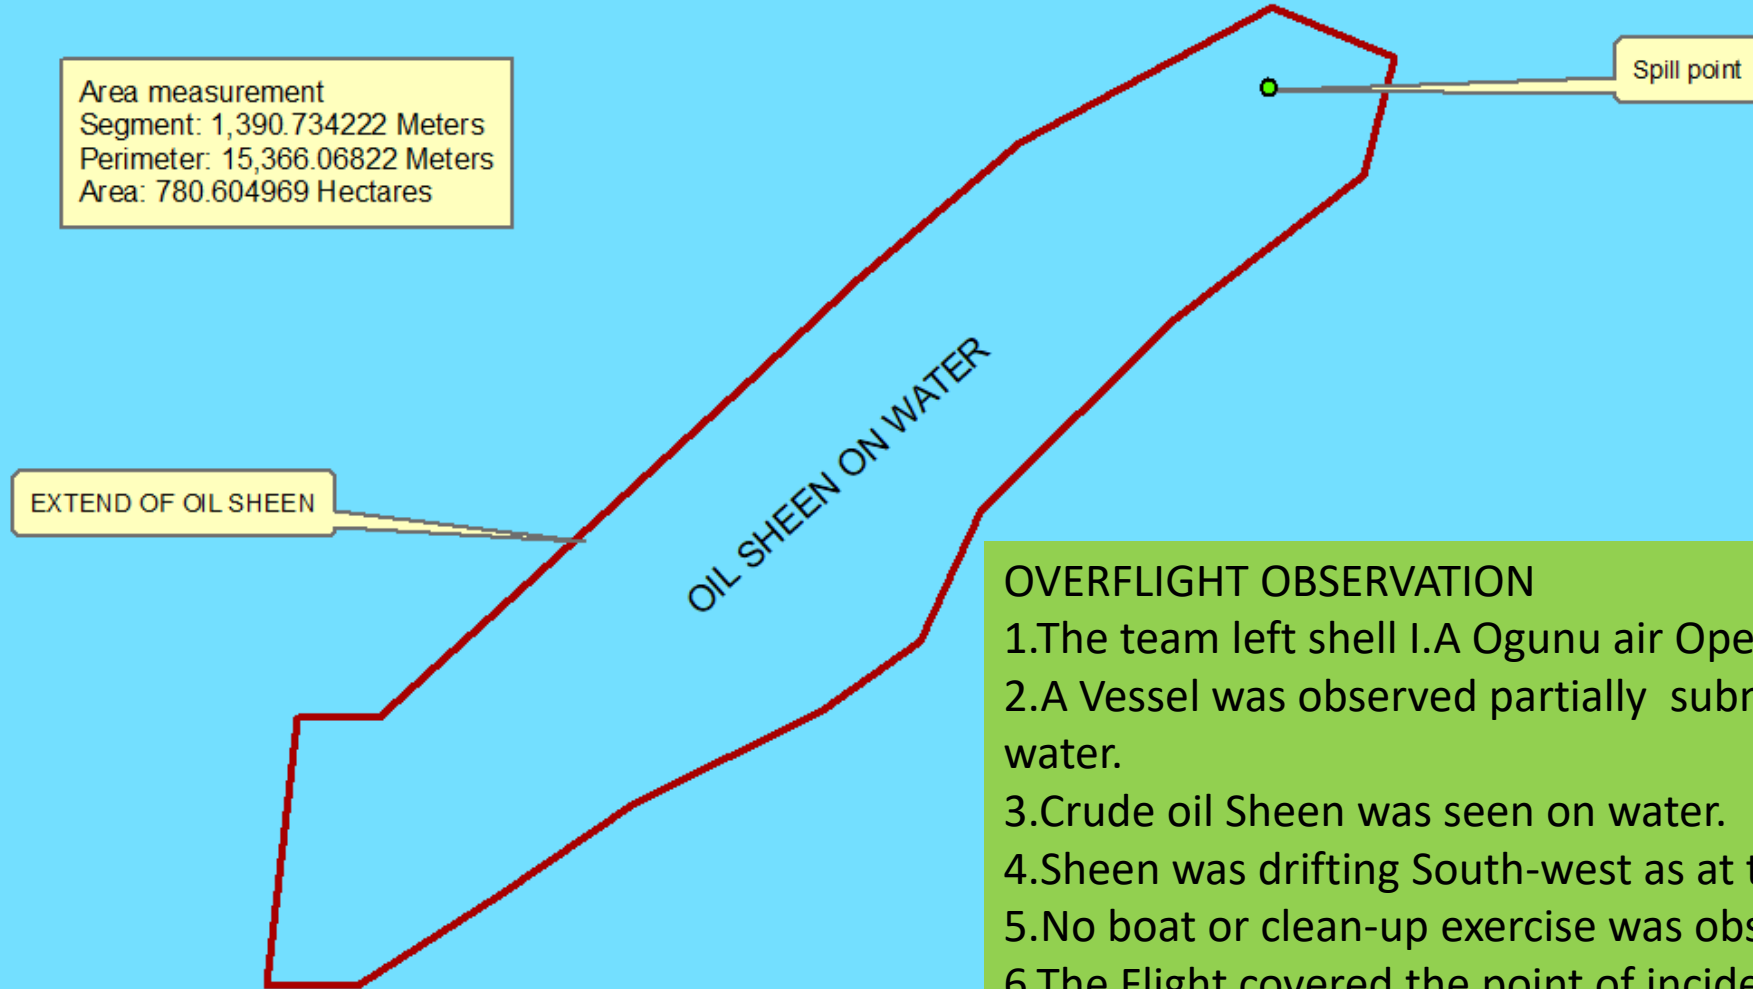
- 1.The team left shell I.A Ogunu air Operation by 1637hrs.
- 2.A Vessel was observed partially submerged in the water.
- 3.Crude oil Sheen was seen on water.
- 4.Sheen was drifting South-west as at the time of overfly
- 5.No boat or clean-up exercise was observed.
- 6.The Flight covered the point of incident and extend of impact.
- 7.Approximate coordinate of spill point:4.8312E, 5.72649N(WGS84)
- 8.Team arrive shell I.A by 1800hrs.

Area measurement  
Segment: 1,390.734222 Meters  
Perimeter: 15,366.06822 Meters  
Area: 780.604969 Hectares

EXTEND OF OIL SHEEN

OIL SHEEN ON WATER
